Resolution 96-8

A RESOLUTION OF THE CITY OF FORT WALTON BEACH, FLORIDA, RELATING TO COMMUNITY REDEVELOPMENT; ACKNOWLEDGING RECEIPT OF A STUDY FINDING THE EXISTENCE OF BLIGHT CONDITIONS IN AN AREA OF THE CITY; DIRECTING CERTAIN ACTIONS BE TAKEN AND NOTICES PUBLISHED; AND PROVIDING AN EFFECTIVE DATE.

SECTION 1. Acknowledge Receipt of Study. The City Council does hereby acknowledge receipt of the study prepared by Carr Smith Associates entitled "Finding of Necessity for the Proposed CRA Area City of Fort Walton Beach" dated as of January, 1996 (the "Carr Smith Study").

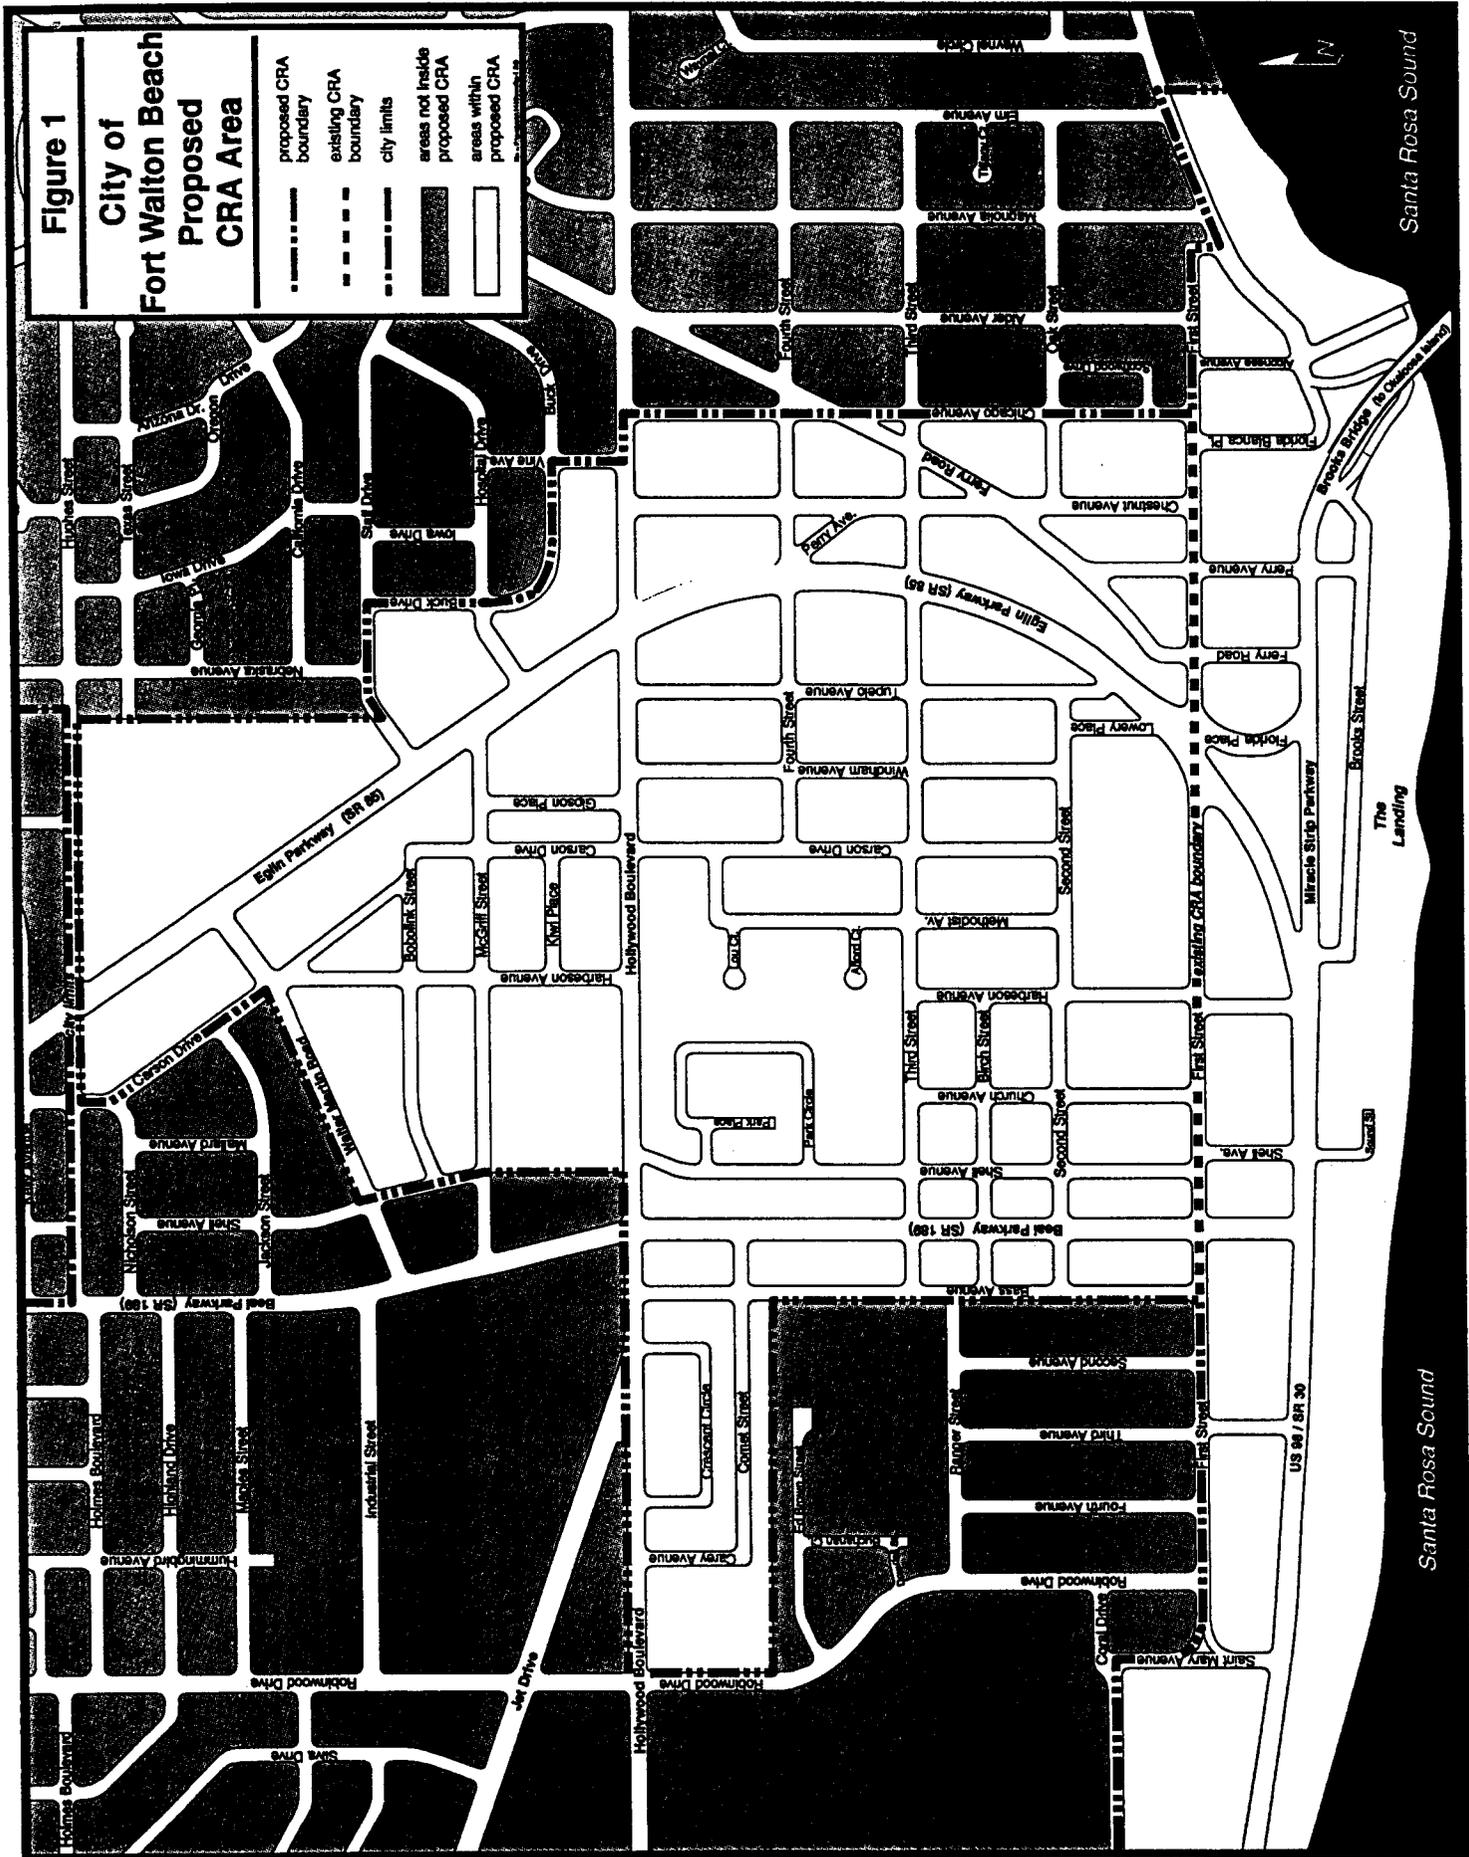
City of Fort Walton Beach Proposed CRA Area

General requirements and objectives for establishing a Community Redevelopment Area have been considered for defining the proposed CRA Area boundaries. The following sections describe the general conditions of the CRA Area which apply to the motivation for recommending its expansion to the proposed boundary. These conditions are based on extensive field observation, data collection, and primary market data collection, and interviews with landowners and civic organizations.

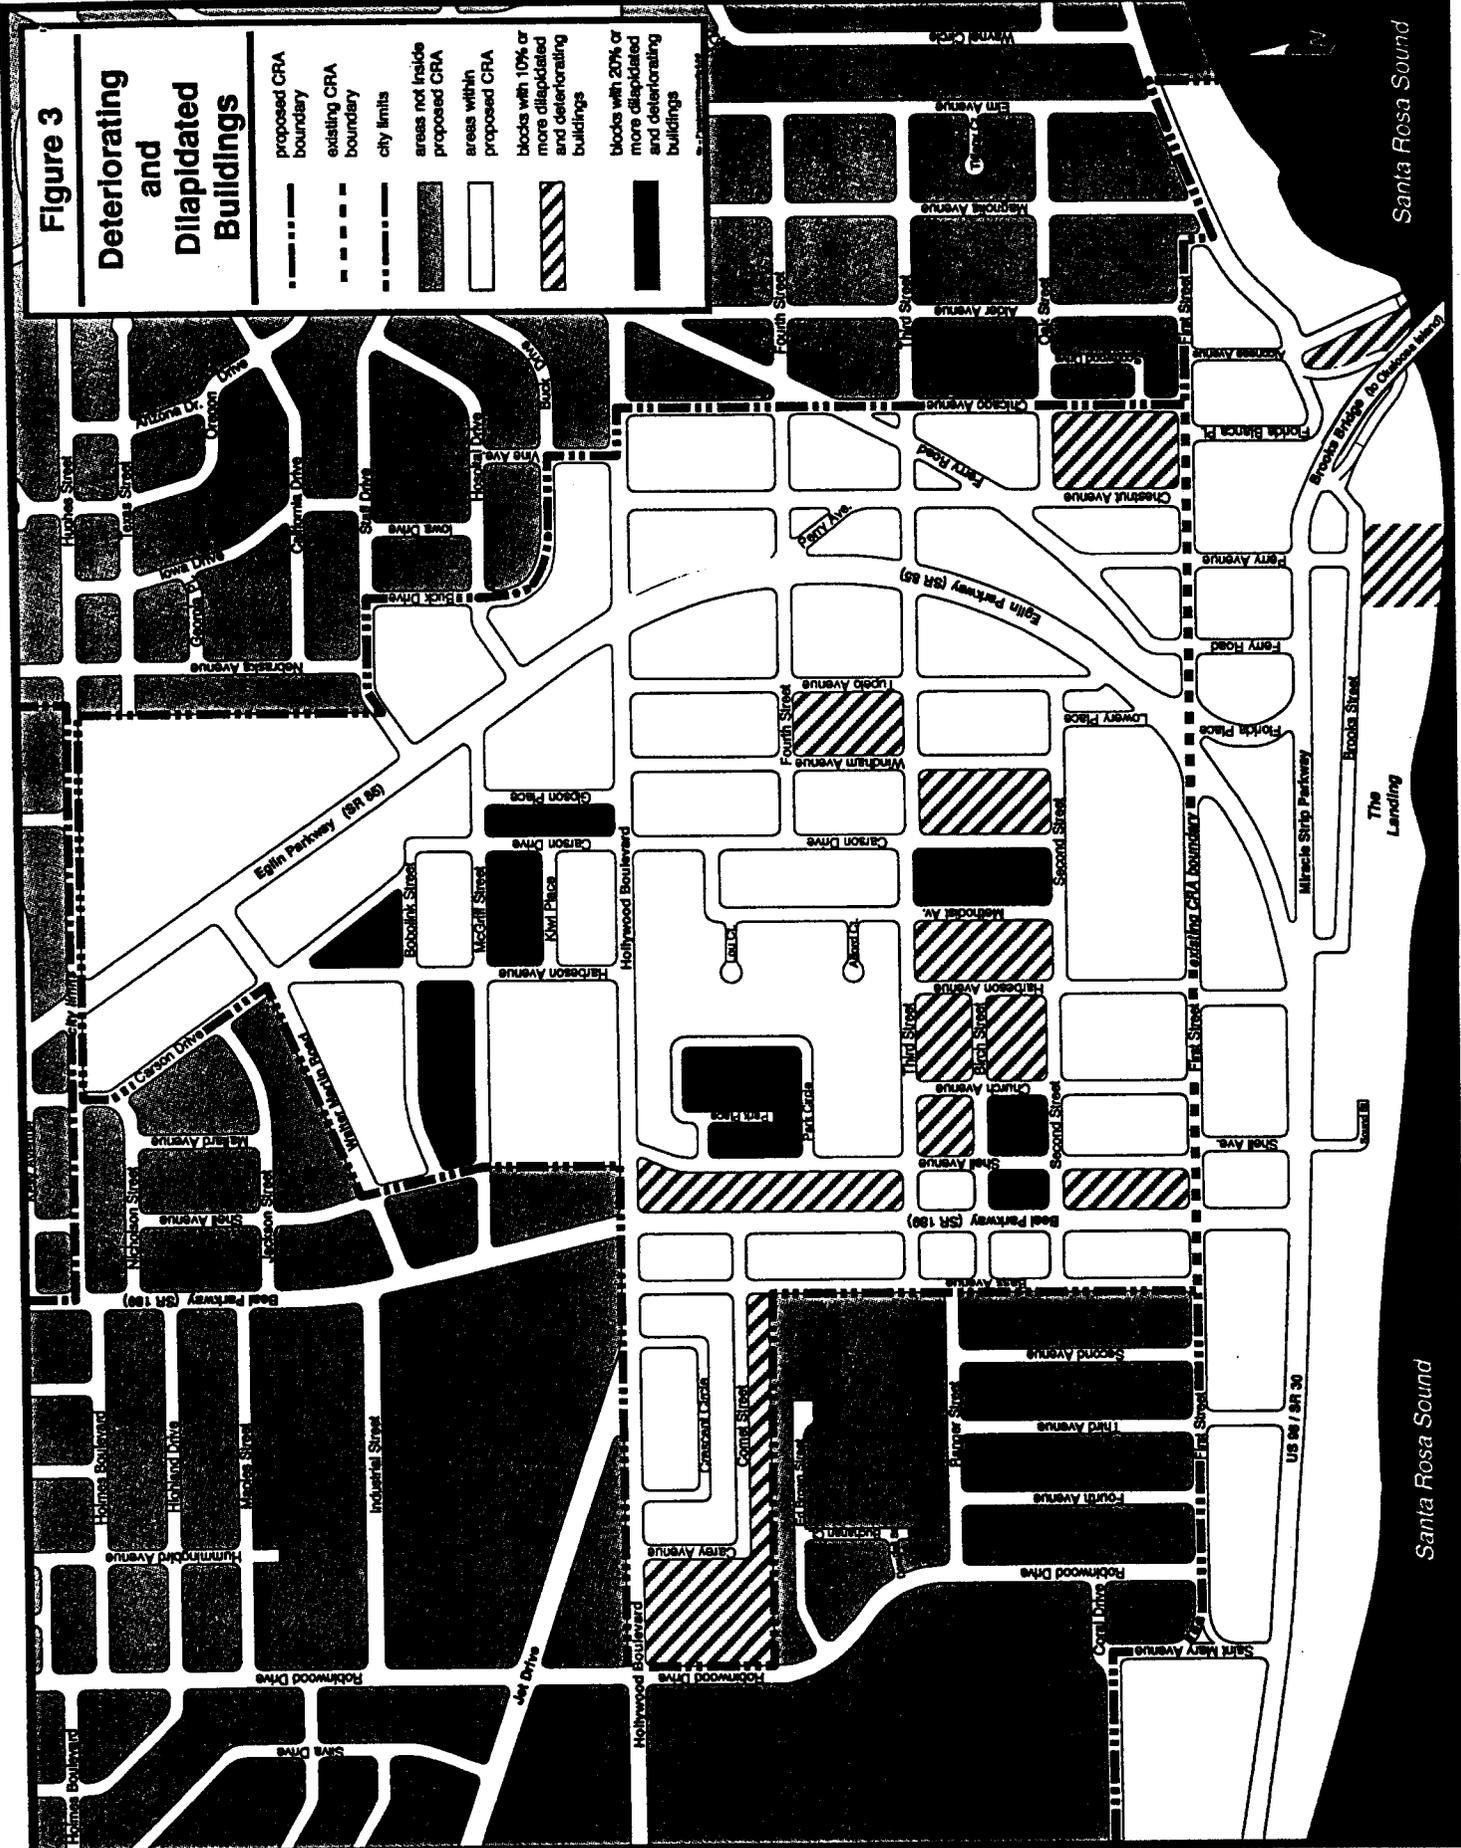
Deteriorating and Dilapidated Buildings

If the proportion of deteriorated and dilapidated structures is such that 20% or more of the properties are effected, the block is considered to be in a blighted condition. If the proportion of deteriorated and dilapidated structures is such that 10% or more of the properties are effected, the block is considered to be in deteriorated condition, and blight is imminent without reinvestment.

As illustrated in Figure 3, nine blocks are blighted by a preponderance of deteriorated or dilapidated structures, and 11 others are deteriorating. Twenty-nine (28.57) acres of the proposed CRA area are thus blighted, and an additional 45.30 acres are significantly deteriorating. Overall, 73.87 acres, approximately 6% of the net developable land in the proposed area is blighted or deteriorating due to dilapidated and deteriorating structures.

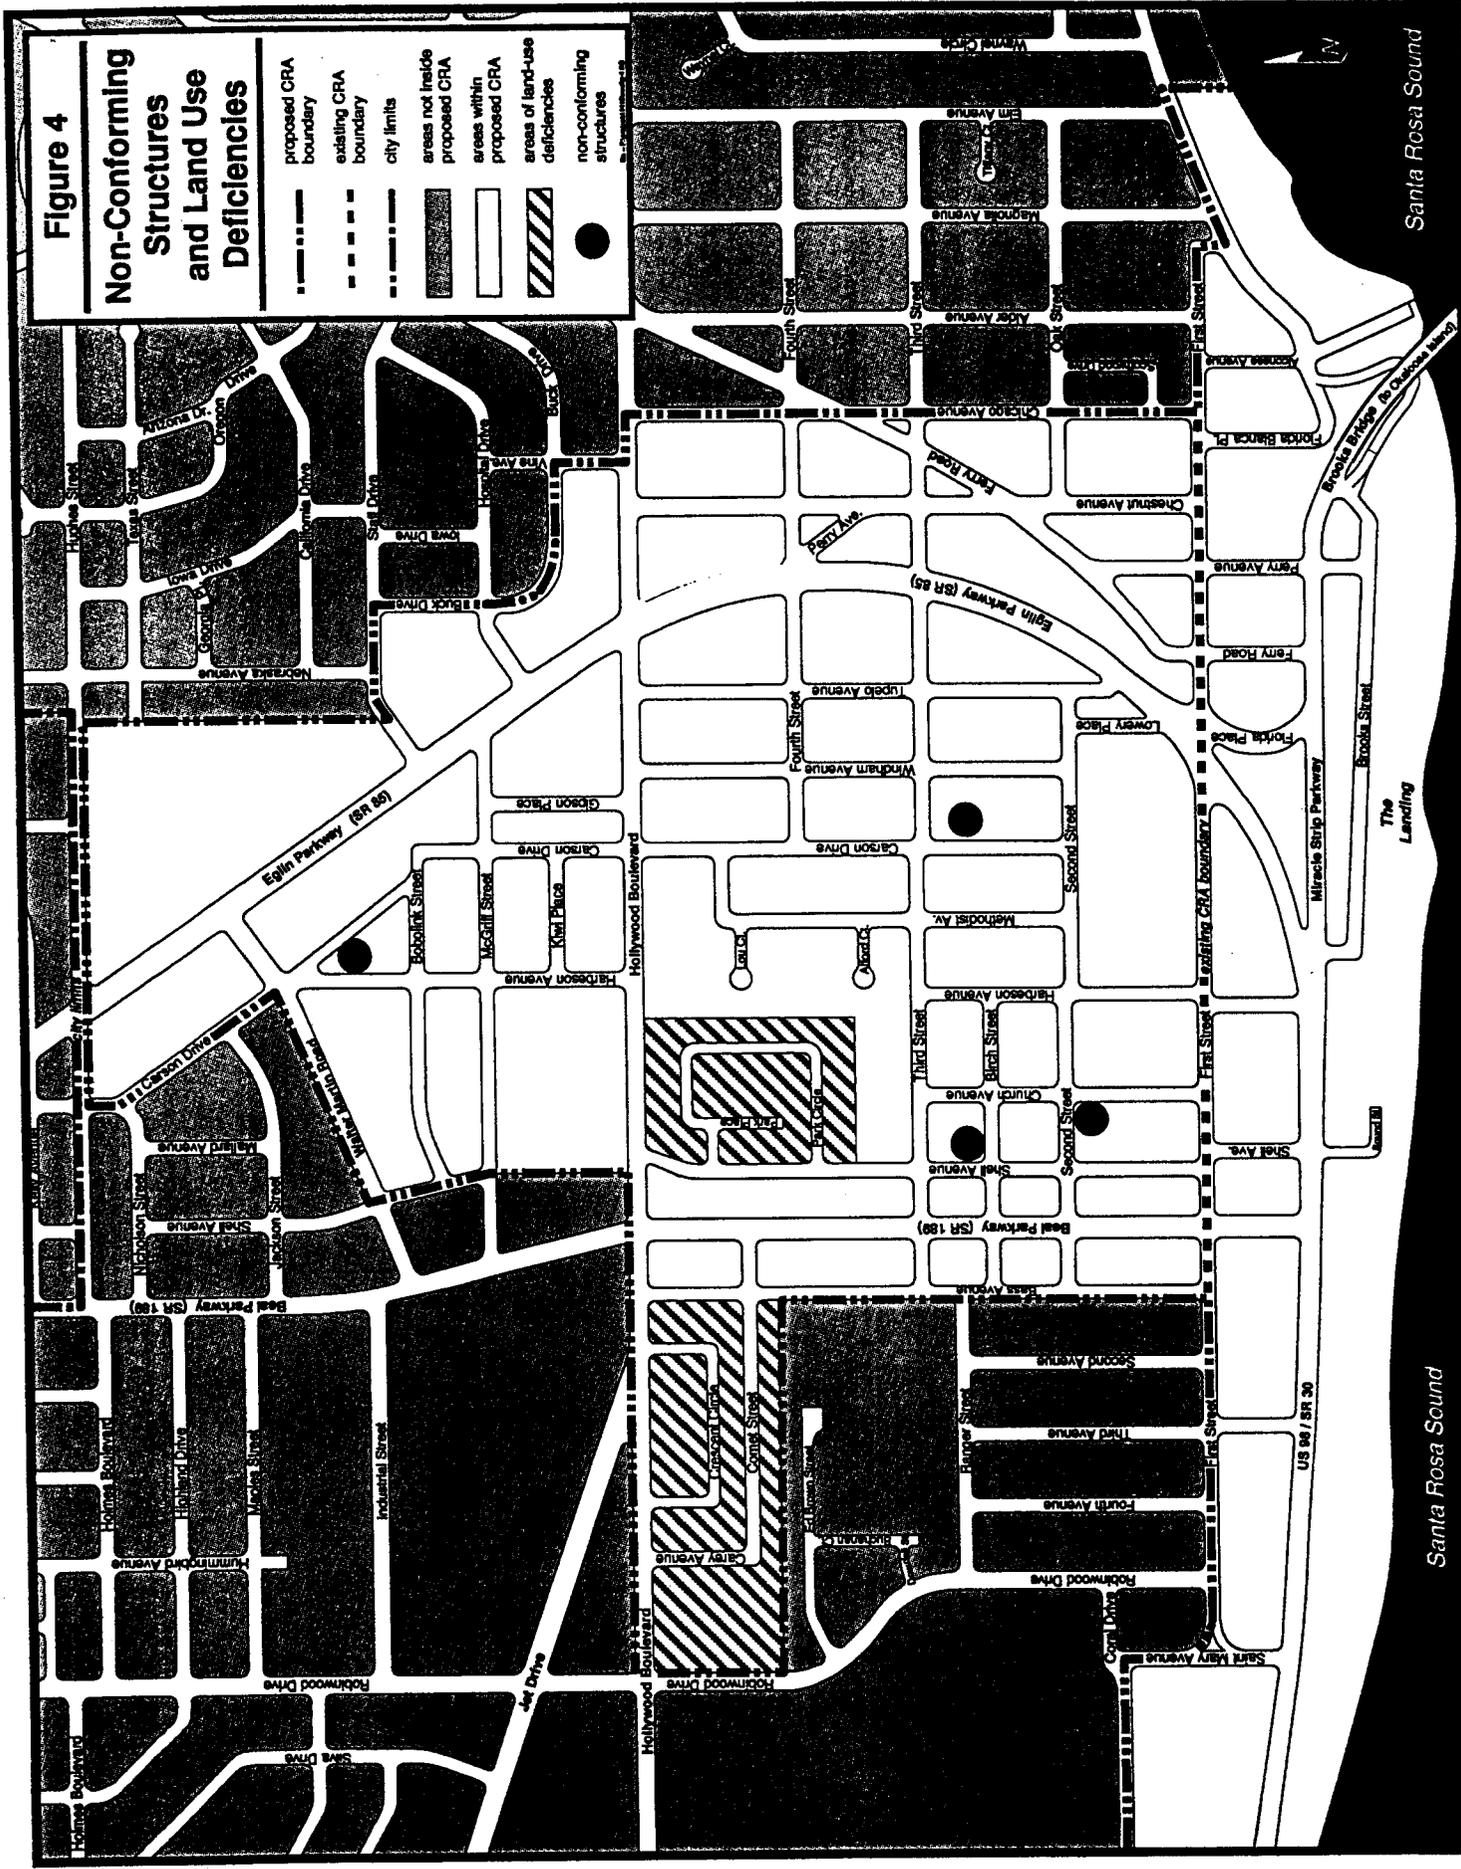
Non-Conforming Structures and Land Use Deficiencies

Four structures were found in the proposed CRA area which do not conform with zoning codes. Their locations are shown in Figure 4.

1. At 12 SE Second Street, the residential structure does not meet the setback requirements of the C-2, General Commercial Zoning District, that the front yard be a minimum of 10 feet, and the side yard, when abutting a residential district, be at least 30 feet.
2. At the 109 SE Shell Avenue (corner of Birch Street), 3B does not meet setback requirements for the R-2 Zoning District: front yard minimum of 25 feet, and side yard minimum of 7.5 feet.
3. At 42 NE Carson Drive, the back of the property, which fronts on Harbeson Avenue is violation of the R-NC Residential-Neighborhood Commercial Zoning District permitted uses. An auto repair operation is on the dwelling site.
4. At 107 SE Carson Drive, the single family residence has a non-conforming apartment at the rear of the building. This is a violation of the R-1 Single-Family Dwelling Residential Zoning District permitted uses.

Three areas, shown in Figure 4 were found to be blighted by conflicting land uses. In the first areas, there are no uses which are inconsistent with zoning requirement; however, the marketability of the residential properties in these areas are impacted by the immediate proximity of commercial uses. The third involves a grandfathered land use which causes blight to proximate residences.

1. The first of these areas is the residential community along Park Circle, in which there are 2 buildings which are dilapidated, and 3 buildings which are in deteriorated condition. The character of Park Circle is that of a single-family residential area. At the southeast corner of Park Circle, Park Circle Condos is a planned unit development of new townhouses which are aimed at a middle-income market; however, this development is sheltered from views of Park Circle and the commercial use at the street's northeast corner. Here, is located the back-lot of an auto-related business on Hollywood Boulevard. On this portion of the lot are stored abandoned automobiles, buses, and other parts and machines. This storage, characteristic of a used auto parts lot, is immediately adjacent to, and visible by the residences along Park Circle. It is possible to revitalize this area as

2. The second of these areas lies along Comet Street, along which there is 1 building which is in deteriorated condition, and 1 building which has burned, and has since been abandoned. The backs of the homes along the north side of Comet Street face onto Crescent Circle, which is a busy service road for several commercial establishments fronting on Crescent Circle or on Hollywood Boulevard. The backs of homes along the south side of Comet Street abut the Fort Walton Beach Housing Development, which is not as well maintained as the Germany Terrace Housing Development. Combined, these impacts detract value from the neighborhood, as evidenced by the abandonment. The Comet Street neighborhood is small, consisting of 21 single-family homes, and located on the edge of a hill, has attractive natural features. To remain a vital neighborhood, investment to stimulate further reinvestment will be needed.

3. At 42 Carson, between Bobolink Street and Walter Martin Road, there is an auto repair operation within a single-family dwelling. This operation takes place at the back of the address, so the auto repairs are visible to and cause blight to the homes along Harbeson Avenue, between Bobolink Street and Walter Martin Road. There are five single-family residences along this segment of Harbeson Avenue.

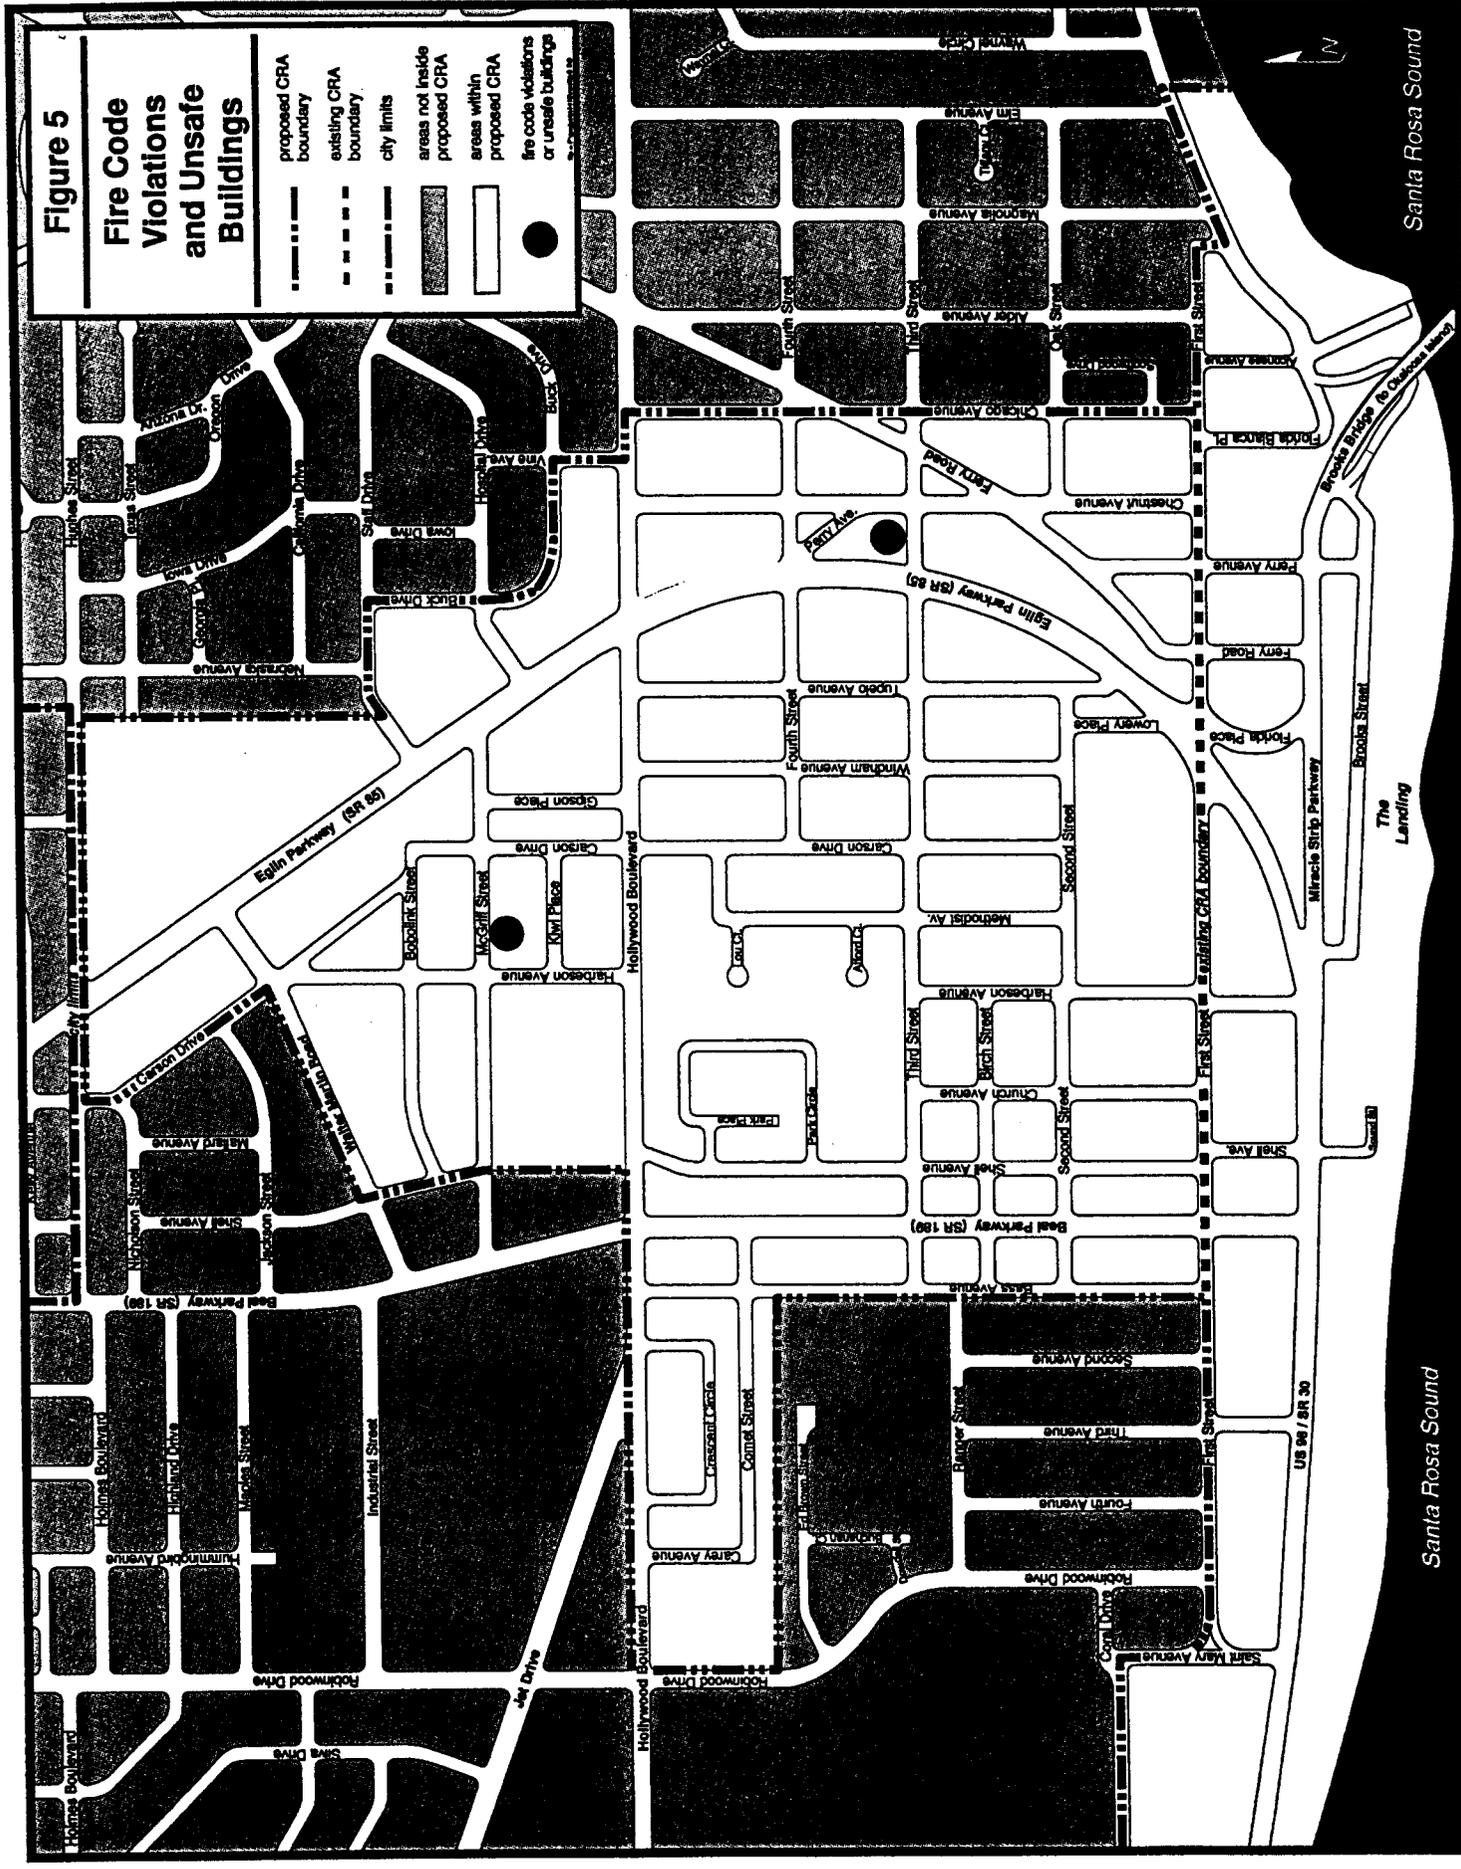
Figure 5 Fire Code Violations and Unsafe Buildings

1. The structure is unsafe as visible from the outside of the building. The building's major structural elements have given way, such as: fallen floors, a fallen roof, sagging or failed walls, or other major structural elements which have failed.
2. The structure does not meet fire codes, as reported by the Fire Safety Inspector.

There are two structures which were found to be in unsafe condition. Their locations are shown in Figure 5.

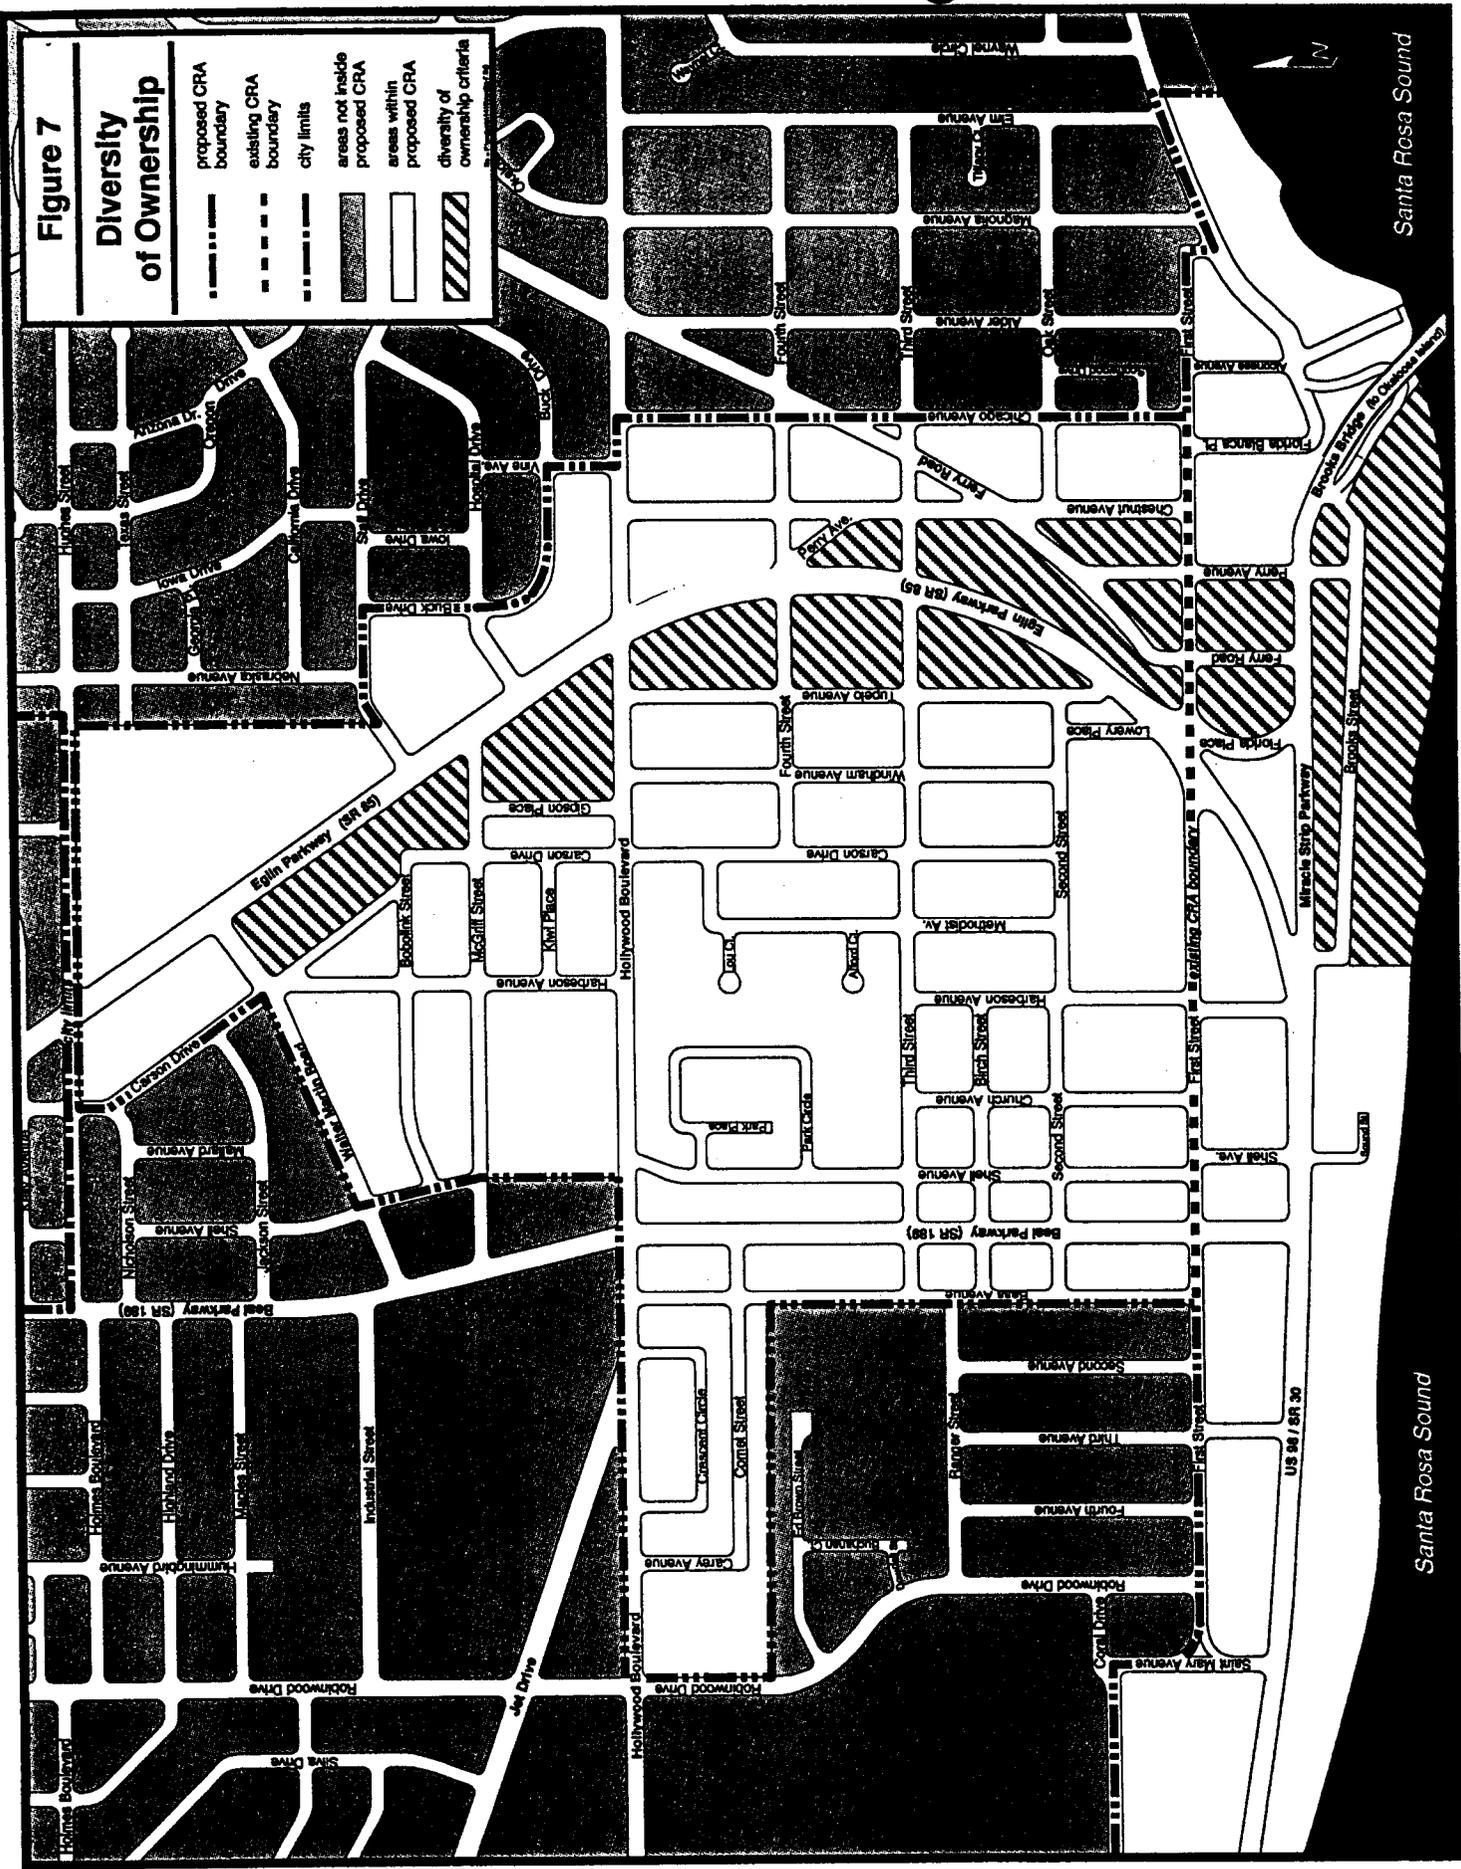
Diversity of Ownership

The blocks which were found to meet the criteria of Section 4.5.2 are shown in Figure 7. These 17 blocks comprise approximately 20% of the proposed CRA area.

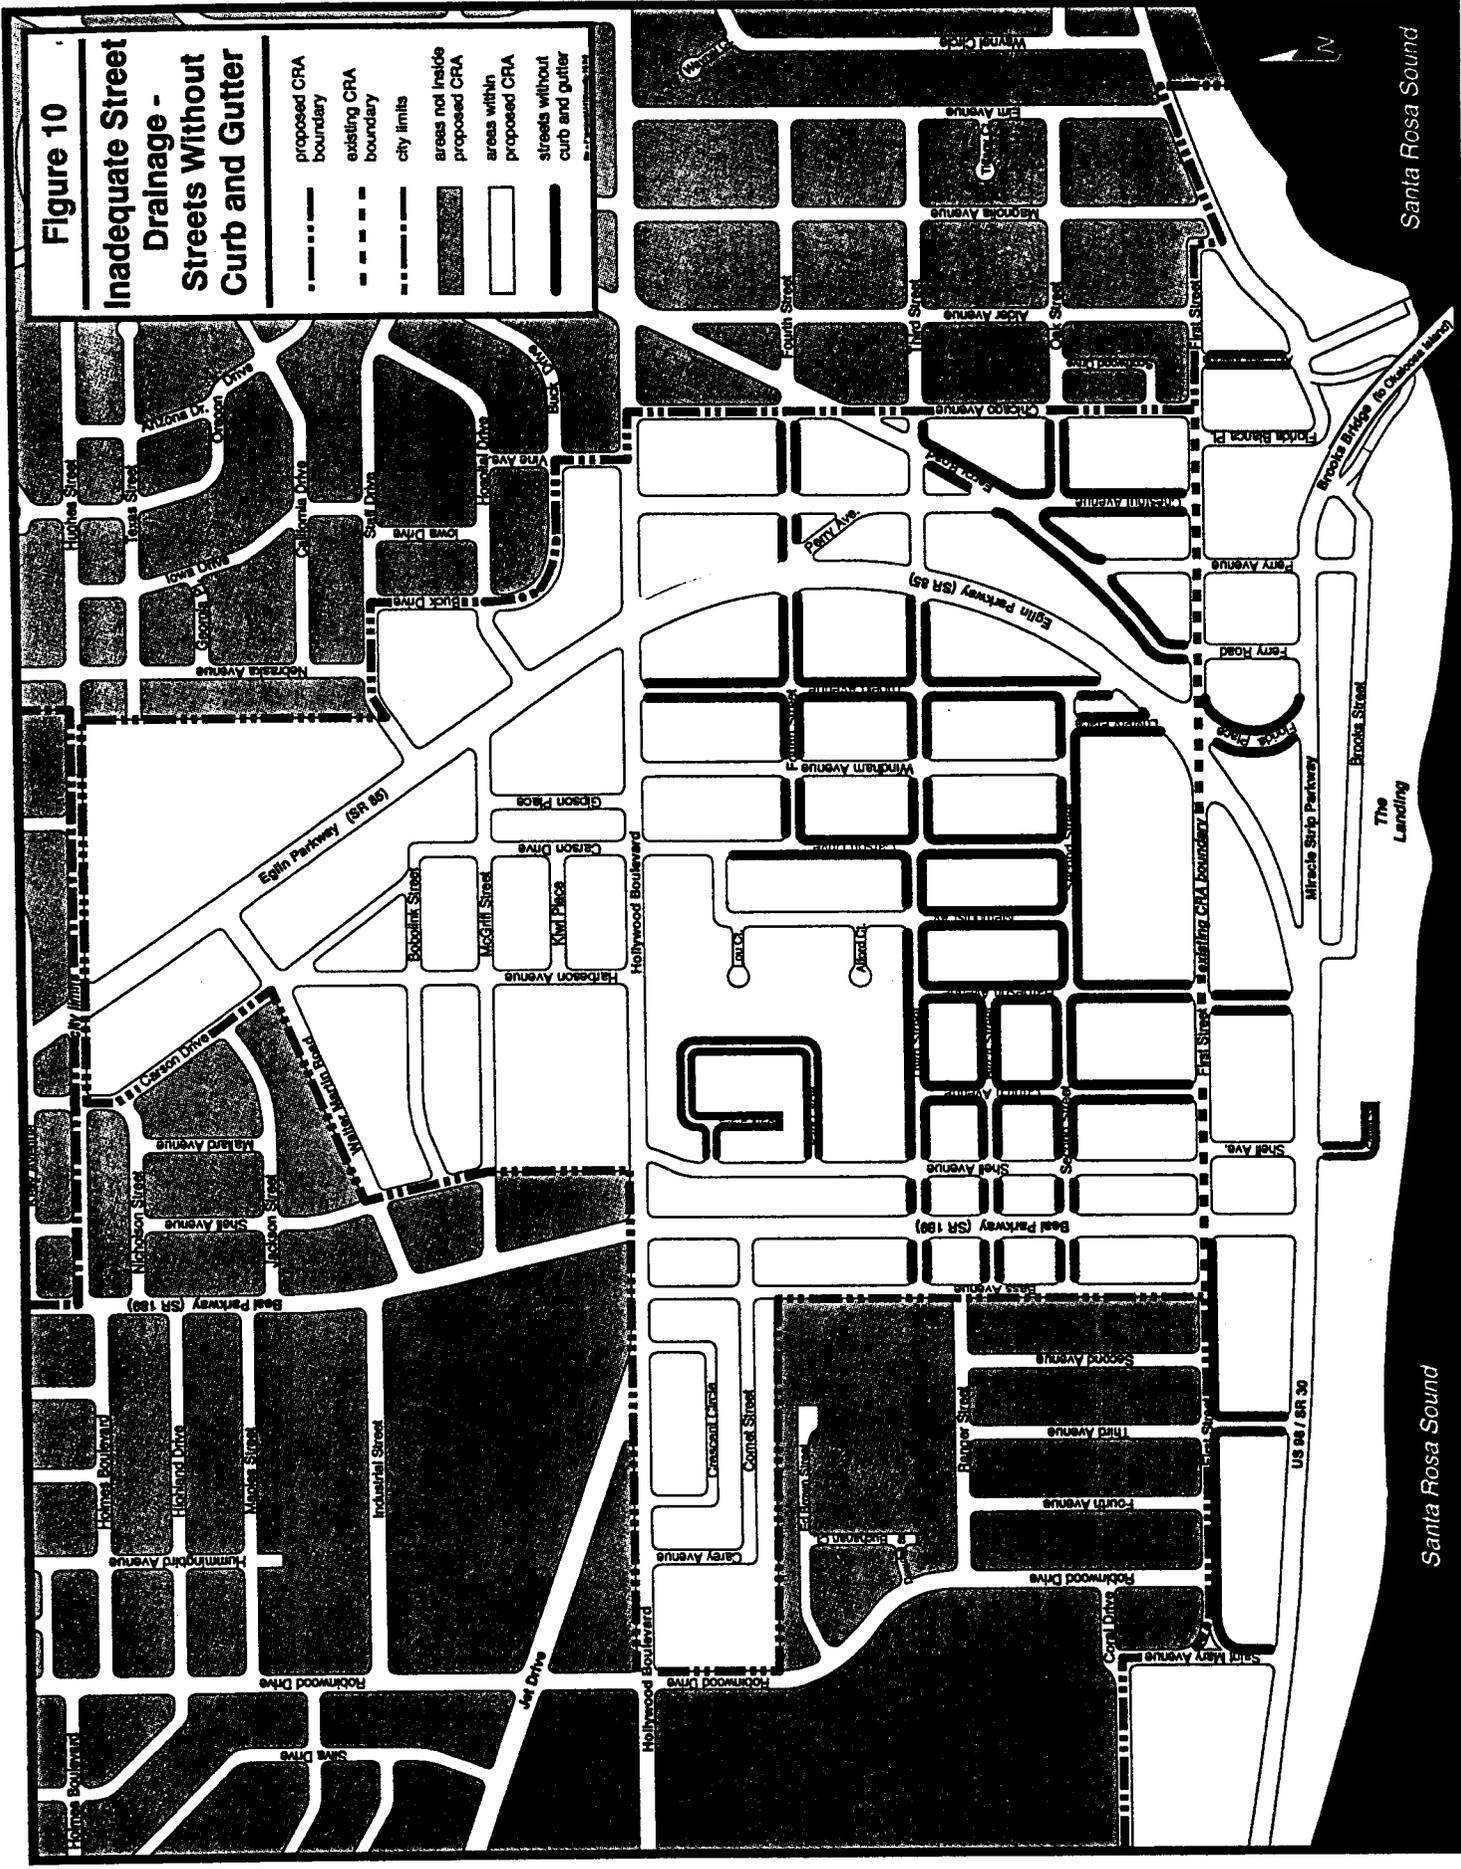
Inadequate Street Drainage - Streets Without Curb and Gutter

The locations of streets without curb and gutter, where curb and gutter is necessary for existing and future development, are shown in Figure 10. Within the CRA area, there are 61 street segments out of 182 which are inadequate because of a lack of curb and gutter. This represents 34% of the links in the street network within the CRA area.

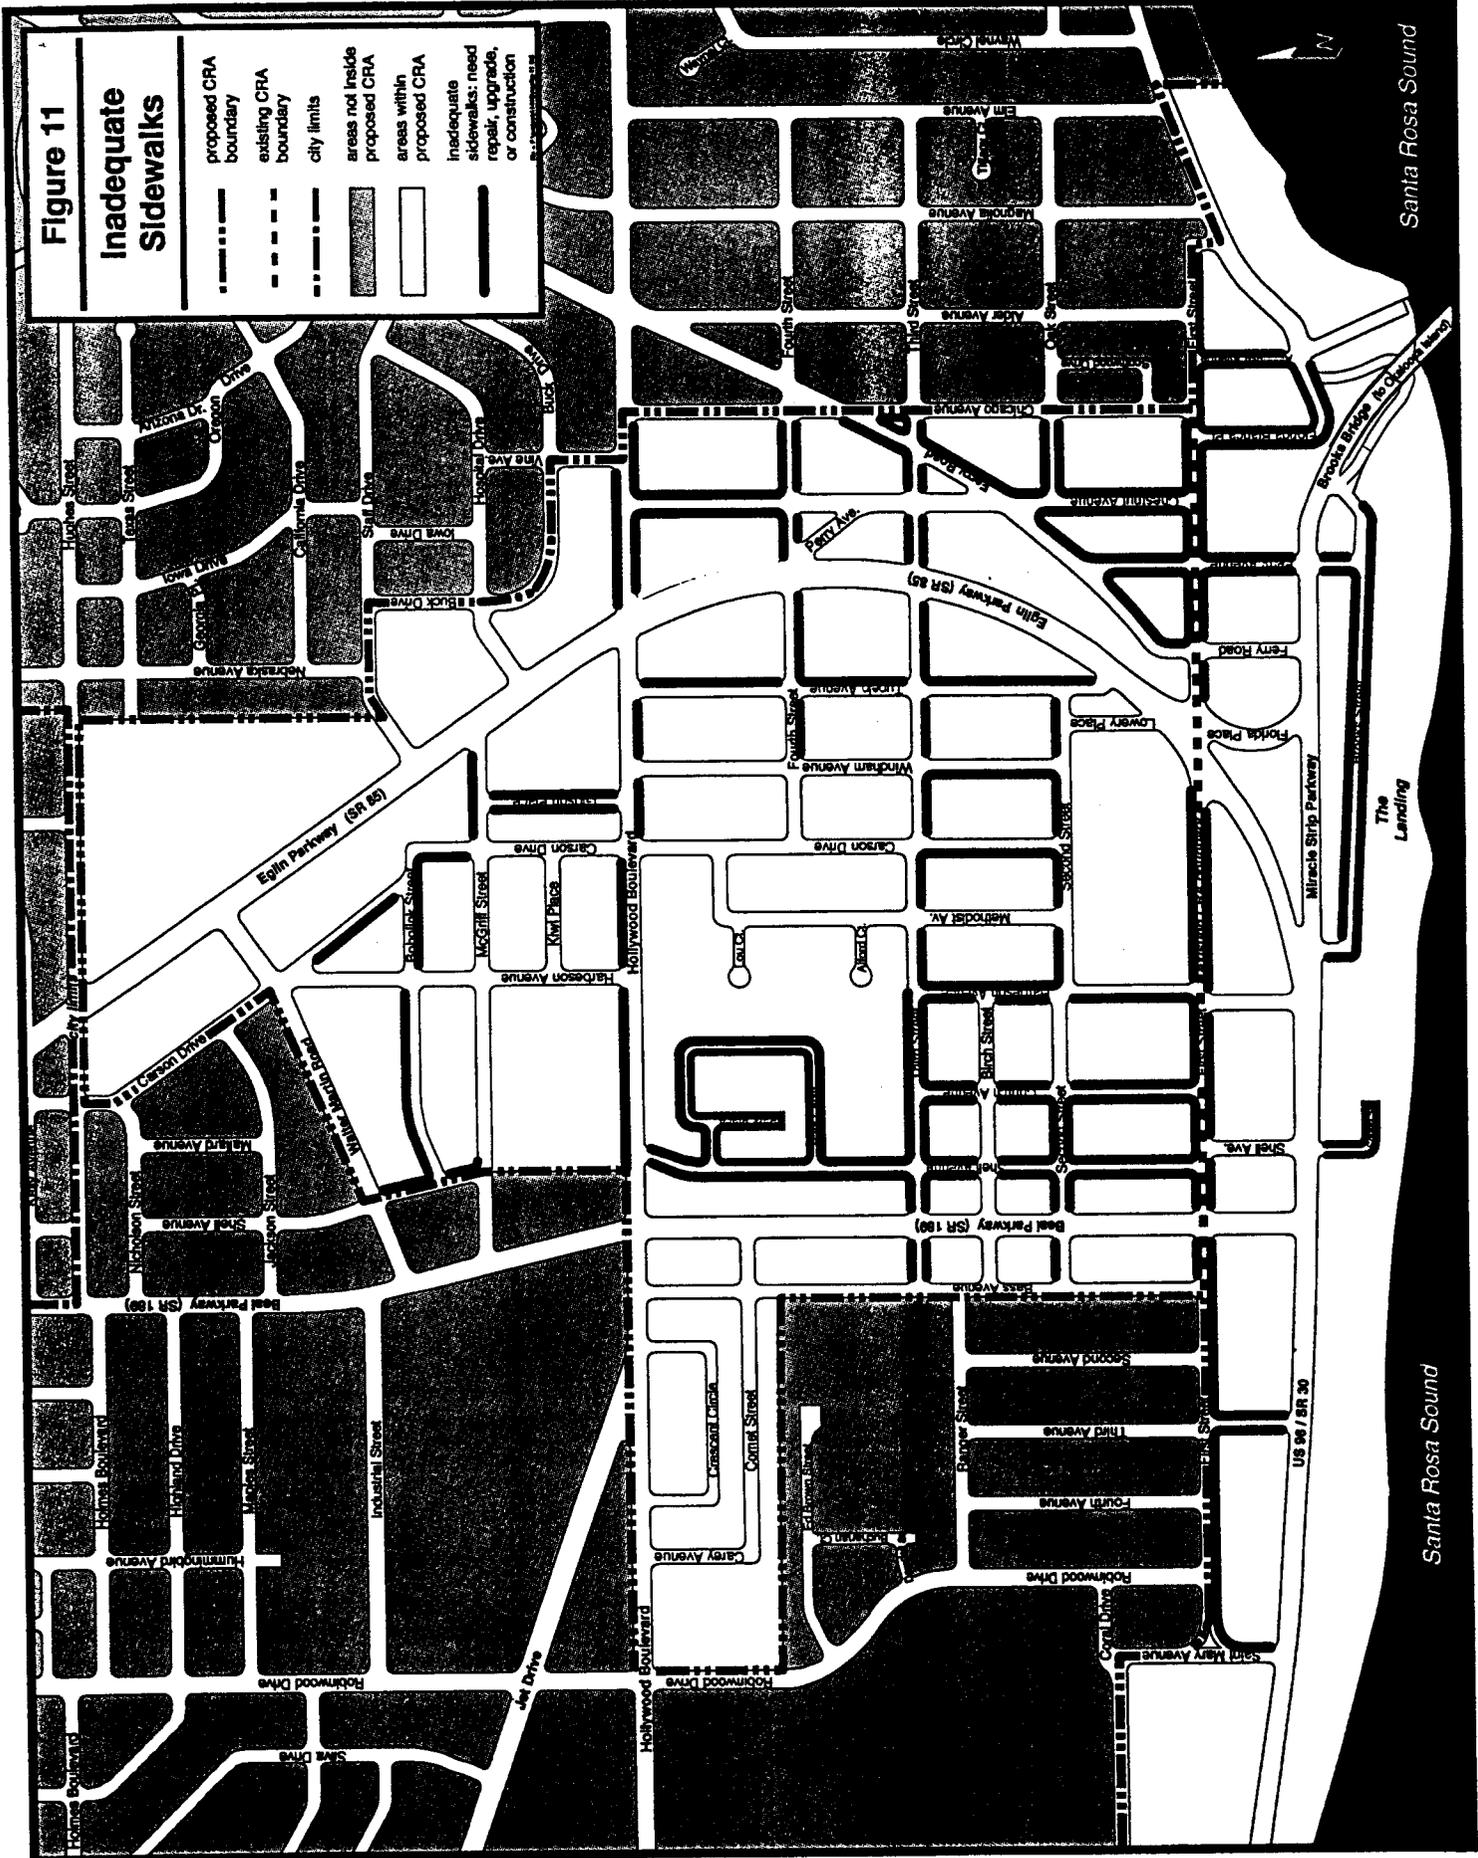
Inadequate Sidewalks

The locations of streets with inadequate sidewalks, in need of repair, upgrade, or construction for existing and future development, are shown in Figure 11. Within the CRA area, there are 94 street segments out of 182 which have inadequate pedestrian circulation. This represents 52% of the links in the street network within the CRA area.
