Resolution 96-8

A RESOLUTION OF THE CITY OF FORT WALTON BEACH, FLORIDA, RELATING TO COMMUNITY REDEVELOPMENT; ACKNOWLEDGING RECEIPT OF A STUDY FINDING THE EXISTENCE OF BLIGHT CONDITIONS IN AN AREA OF THE CITY; DIRECTING CERTAIN ACTIONS BE TAKEN AND NOTICES PUBLISHED; AND PROVIDING AN EFFECTIVE DATE.

SECTION 1. Acknowledge Receipt of Study. The City Council does hereby acknowledge receipt of the study prepared by Carr Smith Associates entitled "Finding of Necessity for the Proposed CRA Area City of Fort Walton Beach" dated as of January, 1996 (the "Carr Smith Study").

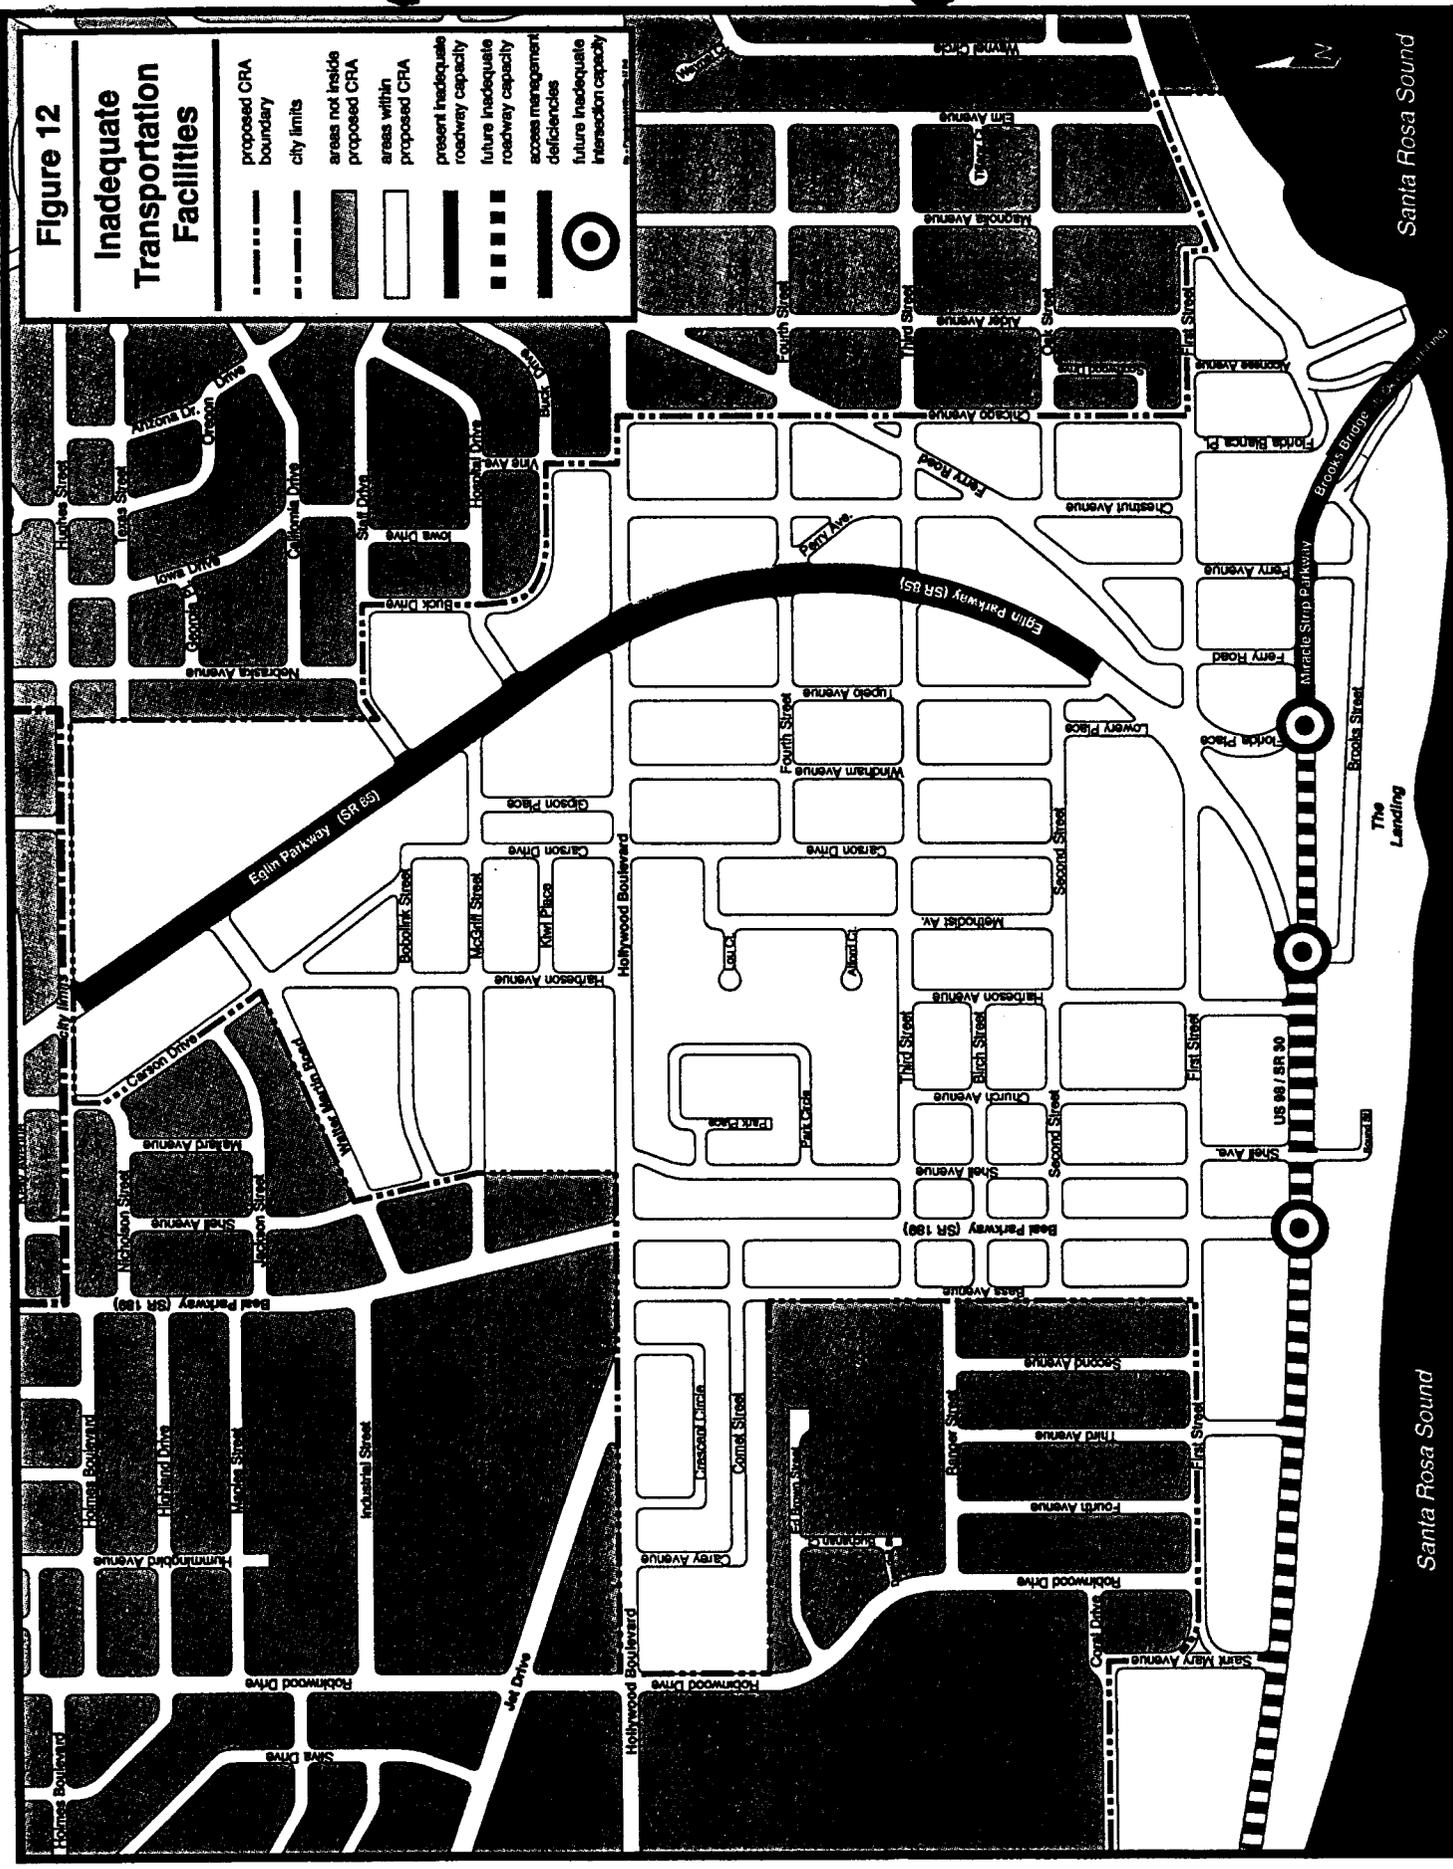
Inadequate Transportation Facilities

The determination of inadequate transportation infrastructure is based on the findings outlined in Section 5. This determination refers to the inadequacy of State and County routes traversing the area, and local City streets which are impacted by deficiencies in the deficient State or County roads. These include:

The inadequacy of these regional links and highways significantly impacts the safety and economic vitality of the CRA area. They have strong functional relationships to safety, private investment, employment, residential development, and the general public interest and welfare of the residents of the City. The inadequacies of these facilities provide a rational target for redevelopment in blocks not individually meeting blight criteria to correct conditions in blighted areas.
