City of Fort Walton Beach
America's Most Beautiful Beaches

A RESOLUTION OF THE CITY OF FORT WALTON BEACH, FLORIDA, RELATING TO COMMUNITY REDEVELOPMENT; FINDING THE EXISTENCE OF BLIGHT CONDITIONS IN AN AREA OF THE CITY; MAKING CERTAIN FINDINGS AND DETERMINATIONS; PROVIDING AN EFFECTIVE DATE.

<u>Section</u>	<u>Page</u>
1.0 FINDING OF NECESSITY SUMMARY	1
1.0 INTRODUCTION	2
2.0 BASIS OF DETERMINATION	2
2.1 BLIGHT	3
2.2 INADEQUATE TRANSPORTATION INFRASTRUCTURE	3
2.3 RESTORATION AND UPKEEP OF HISTORIC STRUCTURES	4
2.4 PRIVATE ENTERPRISE INVESTMENT DISPARITY	4
3.0 PROPOSED CRA AREA BOUNDARY	5
3.1 GENERAL CHARACTERISTICS	8
3.1.1 BLIGHT AND NEED	8
3.1.2 NON-BLIGHTED AREAS	8
3.1.3 DEVELOPMENT OPPORTUNITIES	9
3.1.4 COMPLEMENTS EXISTING PUBLIC AND PRIVATE DEVELOPMENT	9
3.1.5 TAX BASE	9
3.1.6 COMPLEMENT EXISTING CRA	9
3.1.7 COMMUNITY SUPPORT / INCLUSIVENESS	10
3.1.8 CITY VISION	10
4.0 BLIGHT CRITERIA AND FINDINGS	11
4.1 STRUCTURAL CONDITIONS	12
4.1.1 METHODOLOGY	12
4.1.2 CRITERIA	12
4.1.3 FINDINGS	13
4.2 LAND USE DEFICIENCIES	15
4.2.1 METHODOLOGY	15
4.2.2 CRITERIA	15
4.2.3 FINDINGS	16

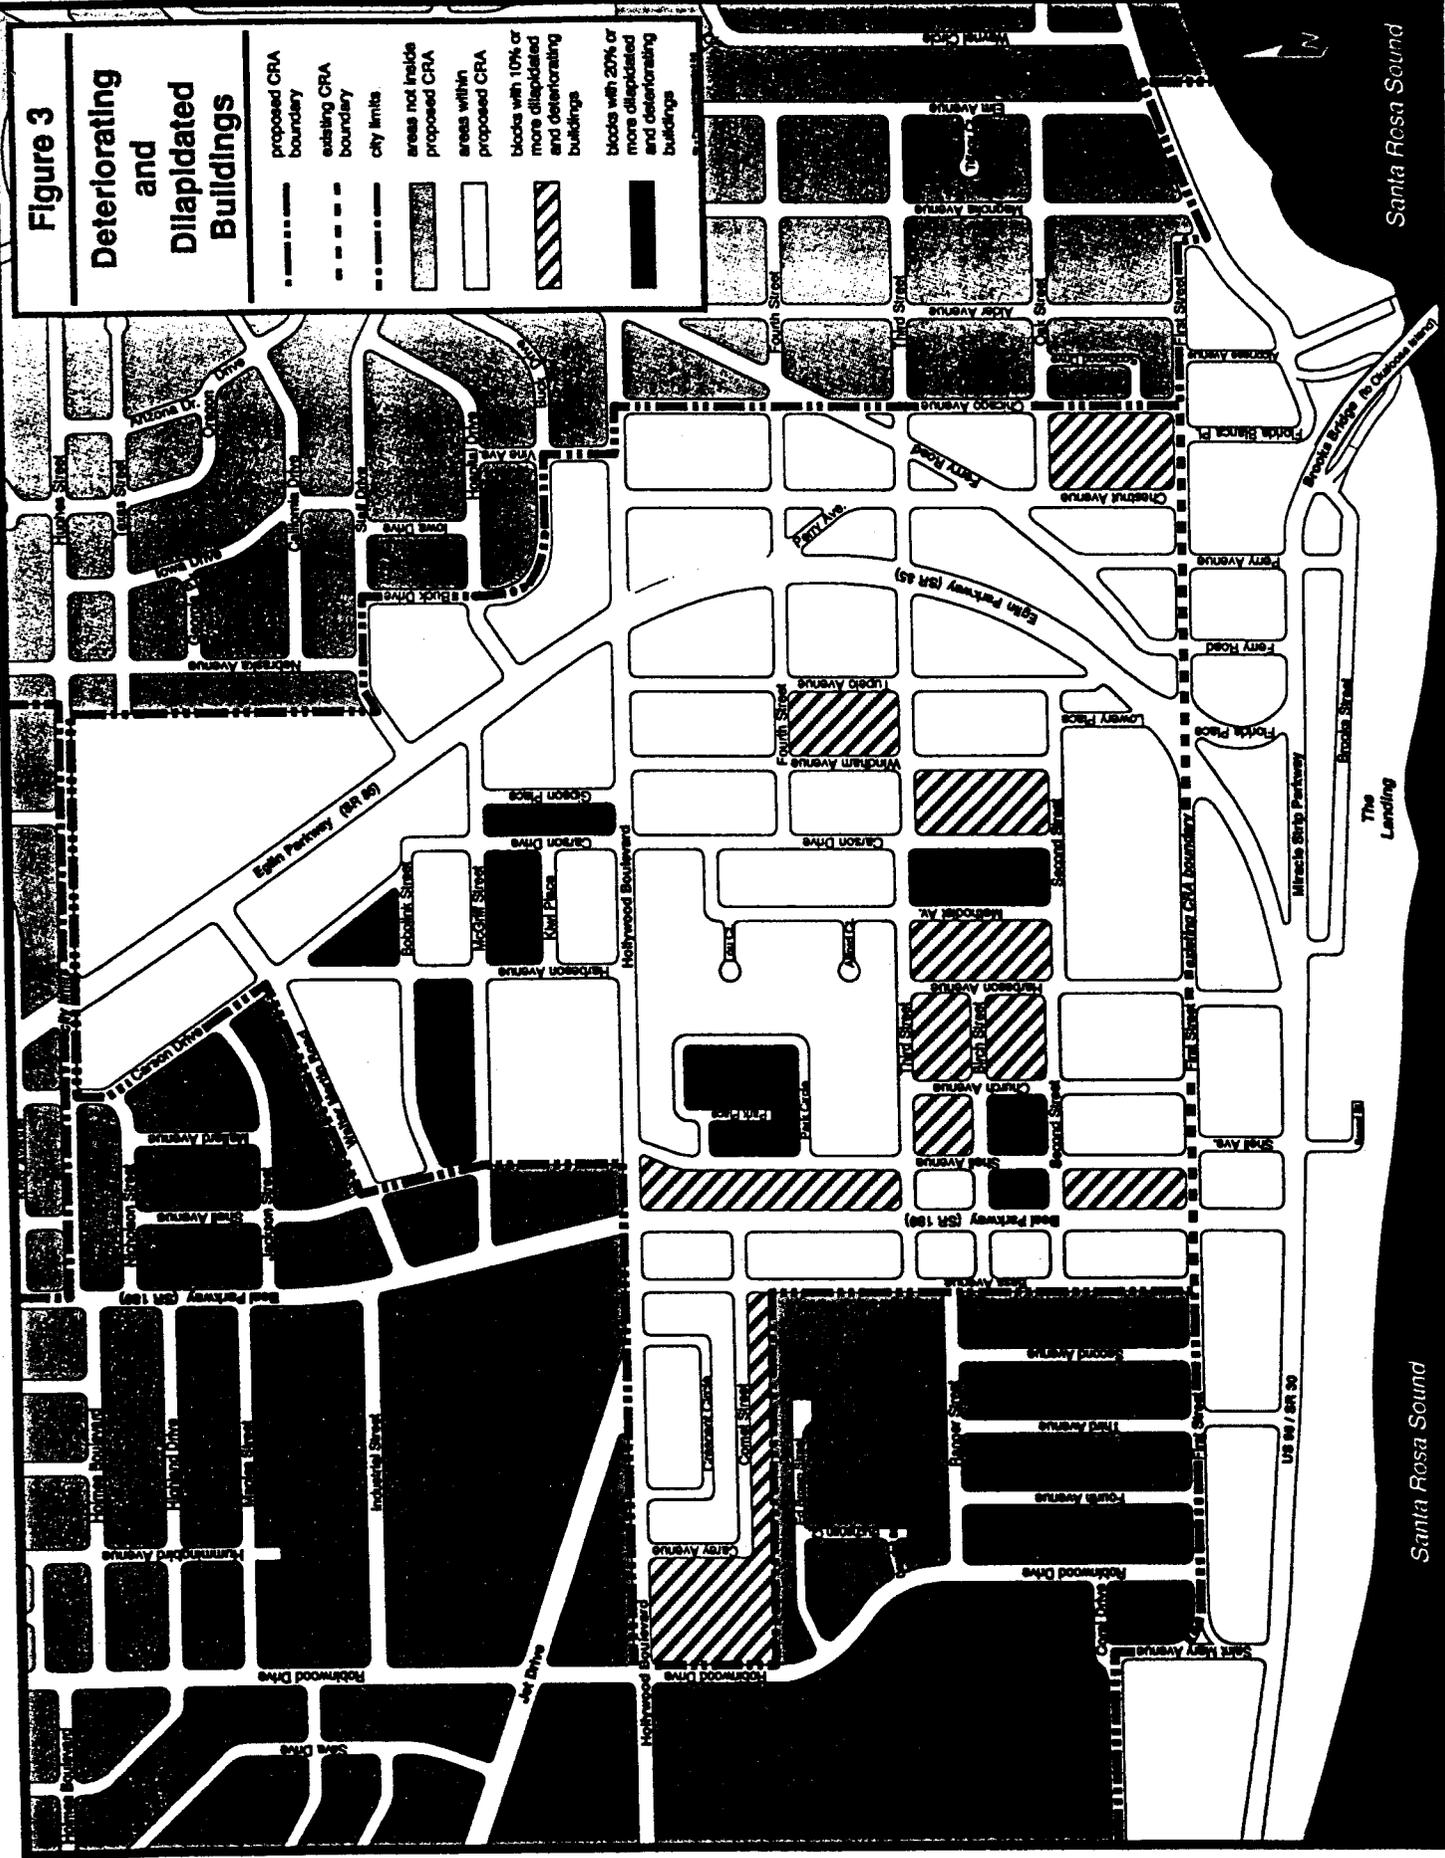
Deteriorating and Dilapidated Buildings

As illustrated in Figure 3, eight blocks are blighted by a preponderance of deteriorated or dilapidated structures, and ten others are deteriorating. Twenty-nine (28.57) acres of the proposed CRA area are thus blighted, and an additional 43.56 acres are significantly deteriorating. Overall, 72.13 acres, approximately 9.4% of the net developable land in the proposed area is blighted or deteriorating due to dilapidated and deteriorating structures.

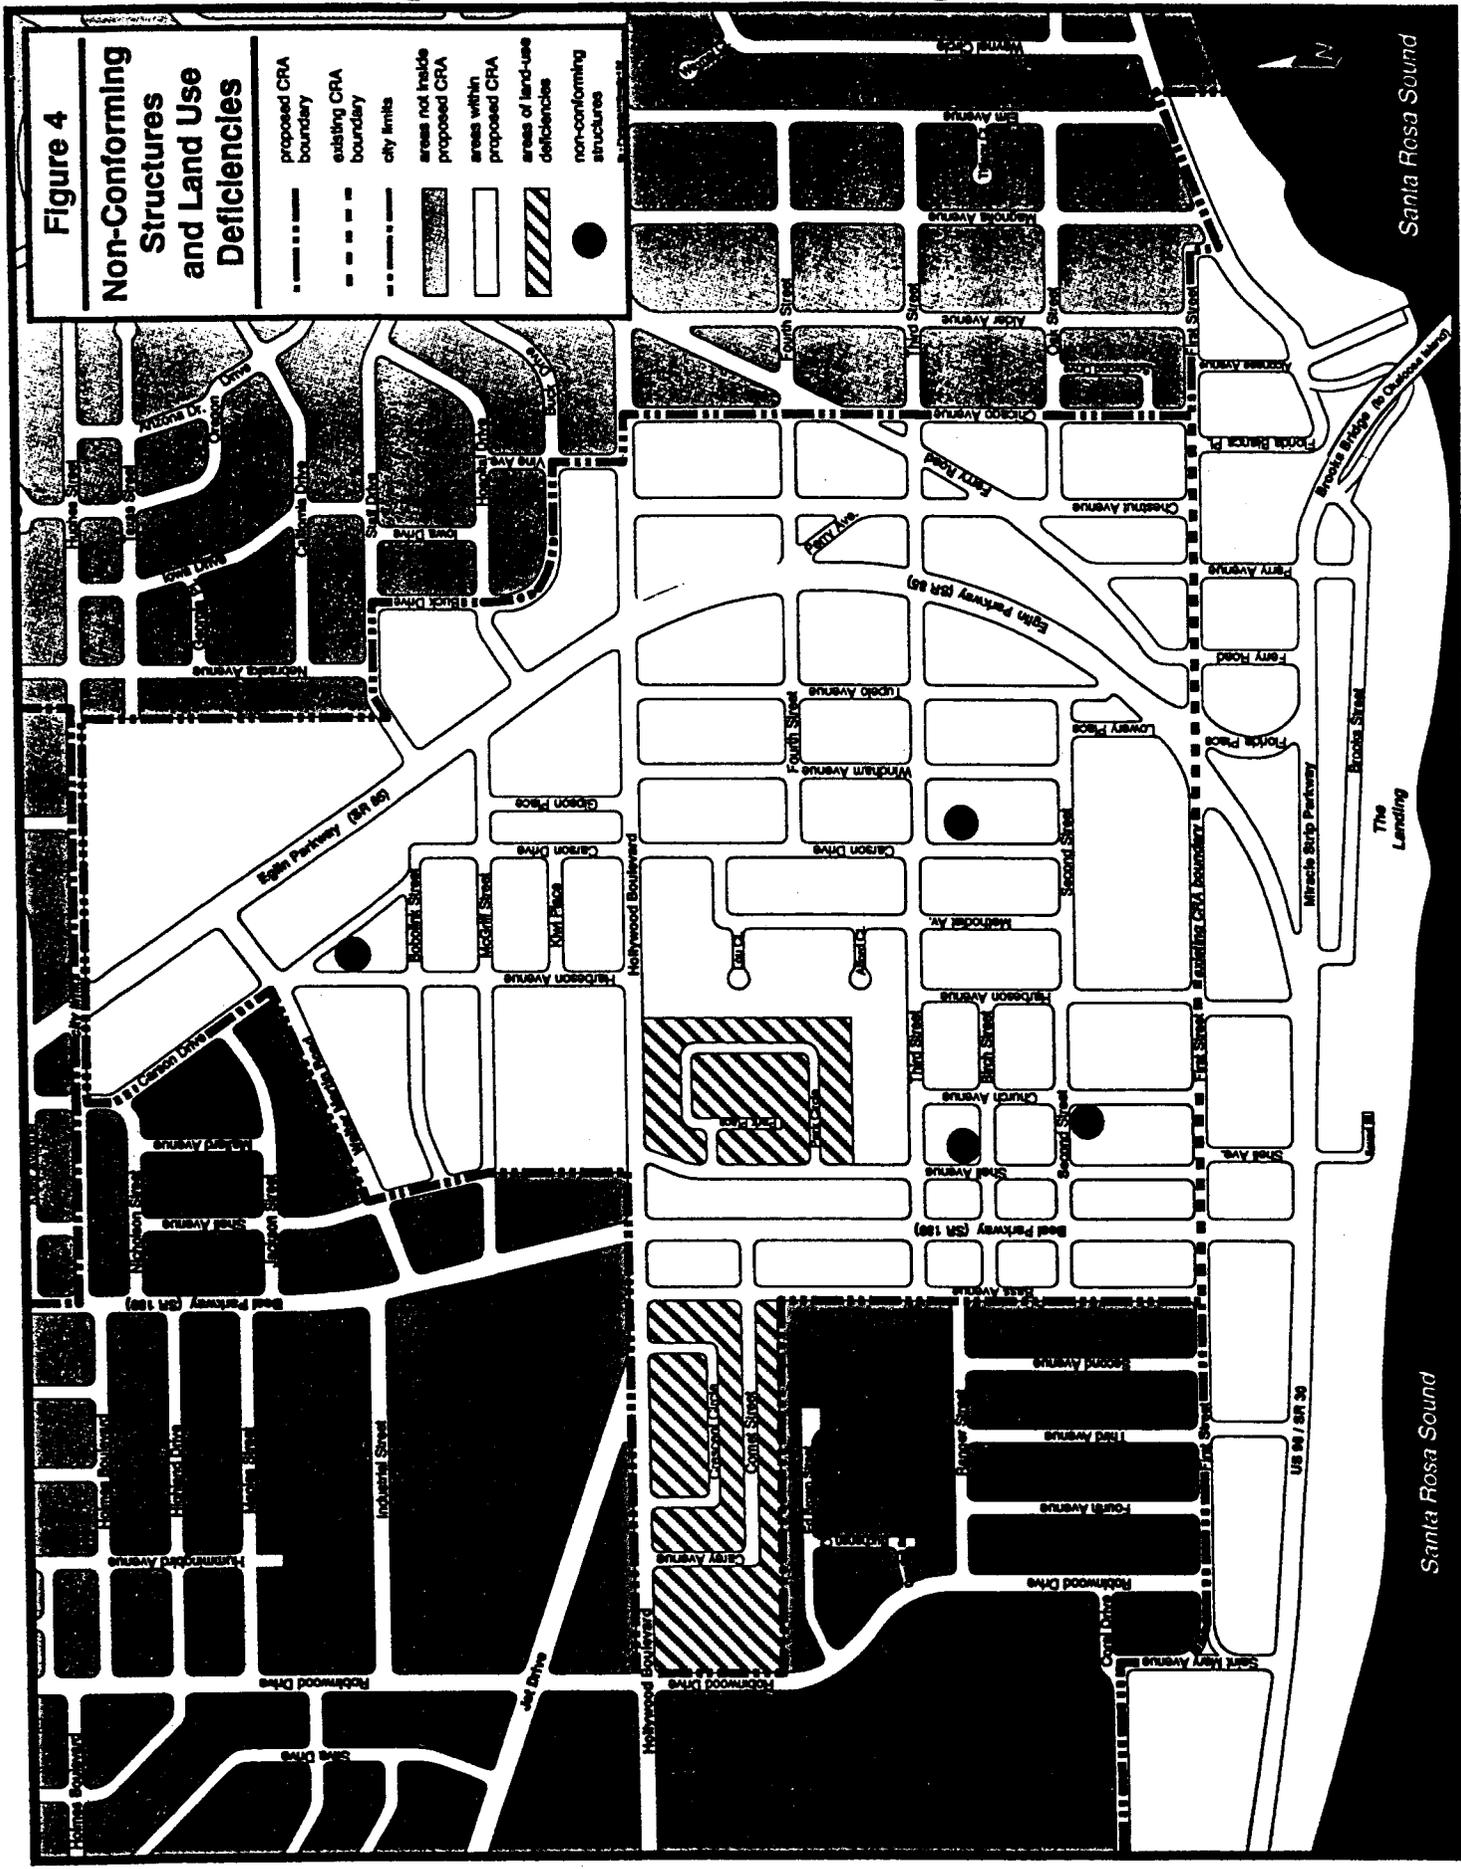
Non-Conforming Structures and Land Use Deficiencies

Four structures were found in the proposed CRA area which do not conform with zoning codes. Their locations are shown in Figure 4.

3. At 42 Carson Drive NE, the back of the property, which fronts on Harbeson Avenue is in violation of the R-NC Residential-Neighborhood Commercial Zoning District permitted uses. An auto repair operation is on the dwelling site. Although this use is grandfathered in, with regard to the finding of blight, its non-conformance with the intent of the zoning district is a cause of blight to other residences along the street.

4. At 107 Carson Drive SE, the single family residence has a non-conforming apartment at the rear of the building. This is a violation of the R-1 Single-Family Dwelling Residential Zoning District permitted uses.

Three areas, shown in Figure 4 were found to be blighted by conflicting land uses. In the first areas, there are no uses which are inconsistent with zoning requirement; however, the marketability of the residential properties in these areas are impacted by the immediate proximity of commercial uses. The third involves a grandfathered land use which causes blight to proximate residences.

1. The first of these areas is the residential community along Park Circle, in which there are 2 buildings which are dilapidated, and 3 buildings which are in deteriorated condition. The character of Park Circle is that of a single-family residential area. At the southeast corner of Park Circle, Park Circle Condos is a planned unit development of new townhouses which are aimed at a middle-income market; however, this development is sheltered from views of Park Circle and the commercial use at the street's northeast corner. Here, is located the back-lot of an auto-related business on Hollywood Boulevard. On this portion of the lot are stored abandoned automobiles, buses, and other parts and machines. This storage, characteristic of a used auto parts lot, is immediately adjacent to, and visible by the residences along Park Circle. It is possible to revitalize this area as a quiet residential enclave utilizing the old growth, and the layout of Park Circle;

2. The second of these areas lies along Comet Street, along which there is 1 building which is in deteriorated condition, and 1 building which has burned, and has since been abandoned. The backs of the homes along the north side of Comet Street face onto Crescent Circle, which is a busy service road for several commercial establishments fronting on Crescent Circle or on Hollywood Boulevard. The backs of homes along the south side of Comet Street abut the Fort Walton Beach Housing Development, which is not as well maintained as the Germany Terrace Housing Development. Combined, these impacts detract value from the neighborhood, as evidenced by the abandonment. The Comet Street neighborhood is small, consisting of 21 single-family homes, and located on the edge of a hill, has attractive natural features. To remain a vital neighborhood, investment to stimulate further reinvestment will be needed.

3. At 42 Carson, between Bobolink Street and Walter Martin Road, there is an auto repair operation within a single-family dwelling. This operation takes place at the back of the address, so the auto repairs are visible to and cause blight to the homes along Harbeson Avenue, between Bobolink Street and Walter Martin Road. There are five single-family residences along this segment of Harbeson Avenue.

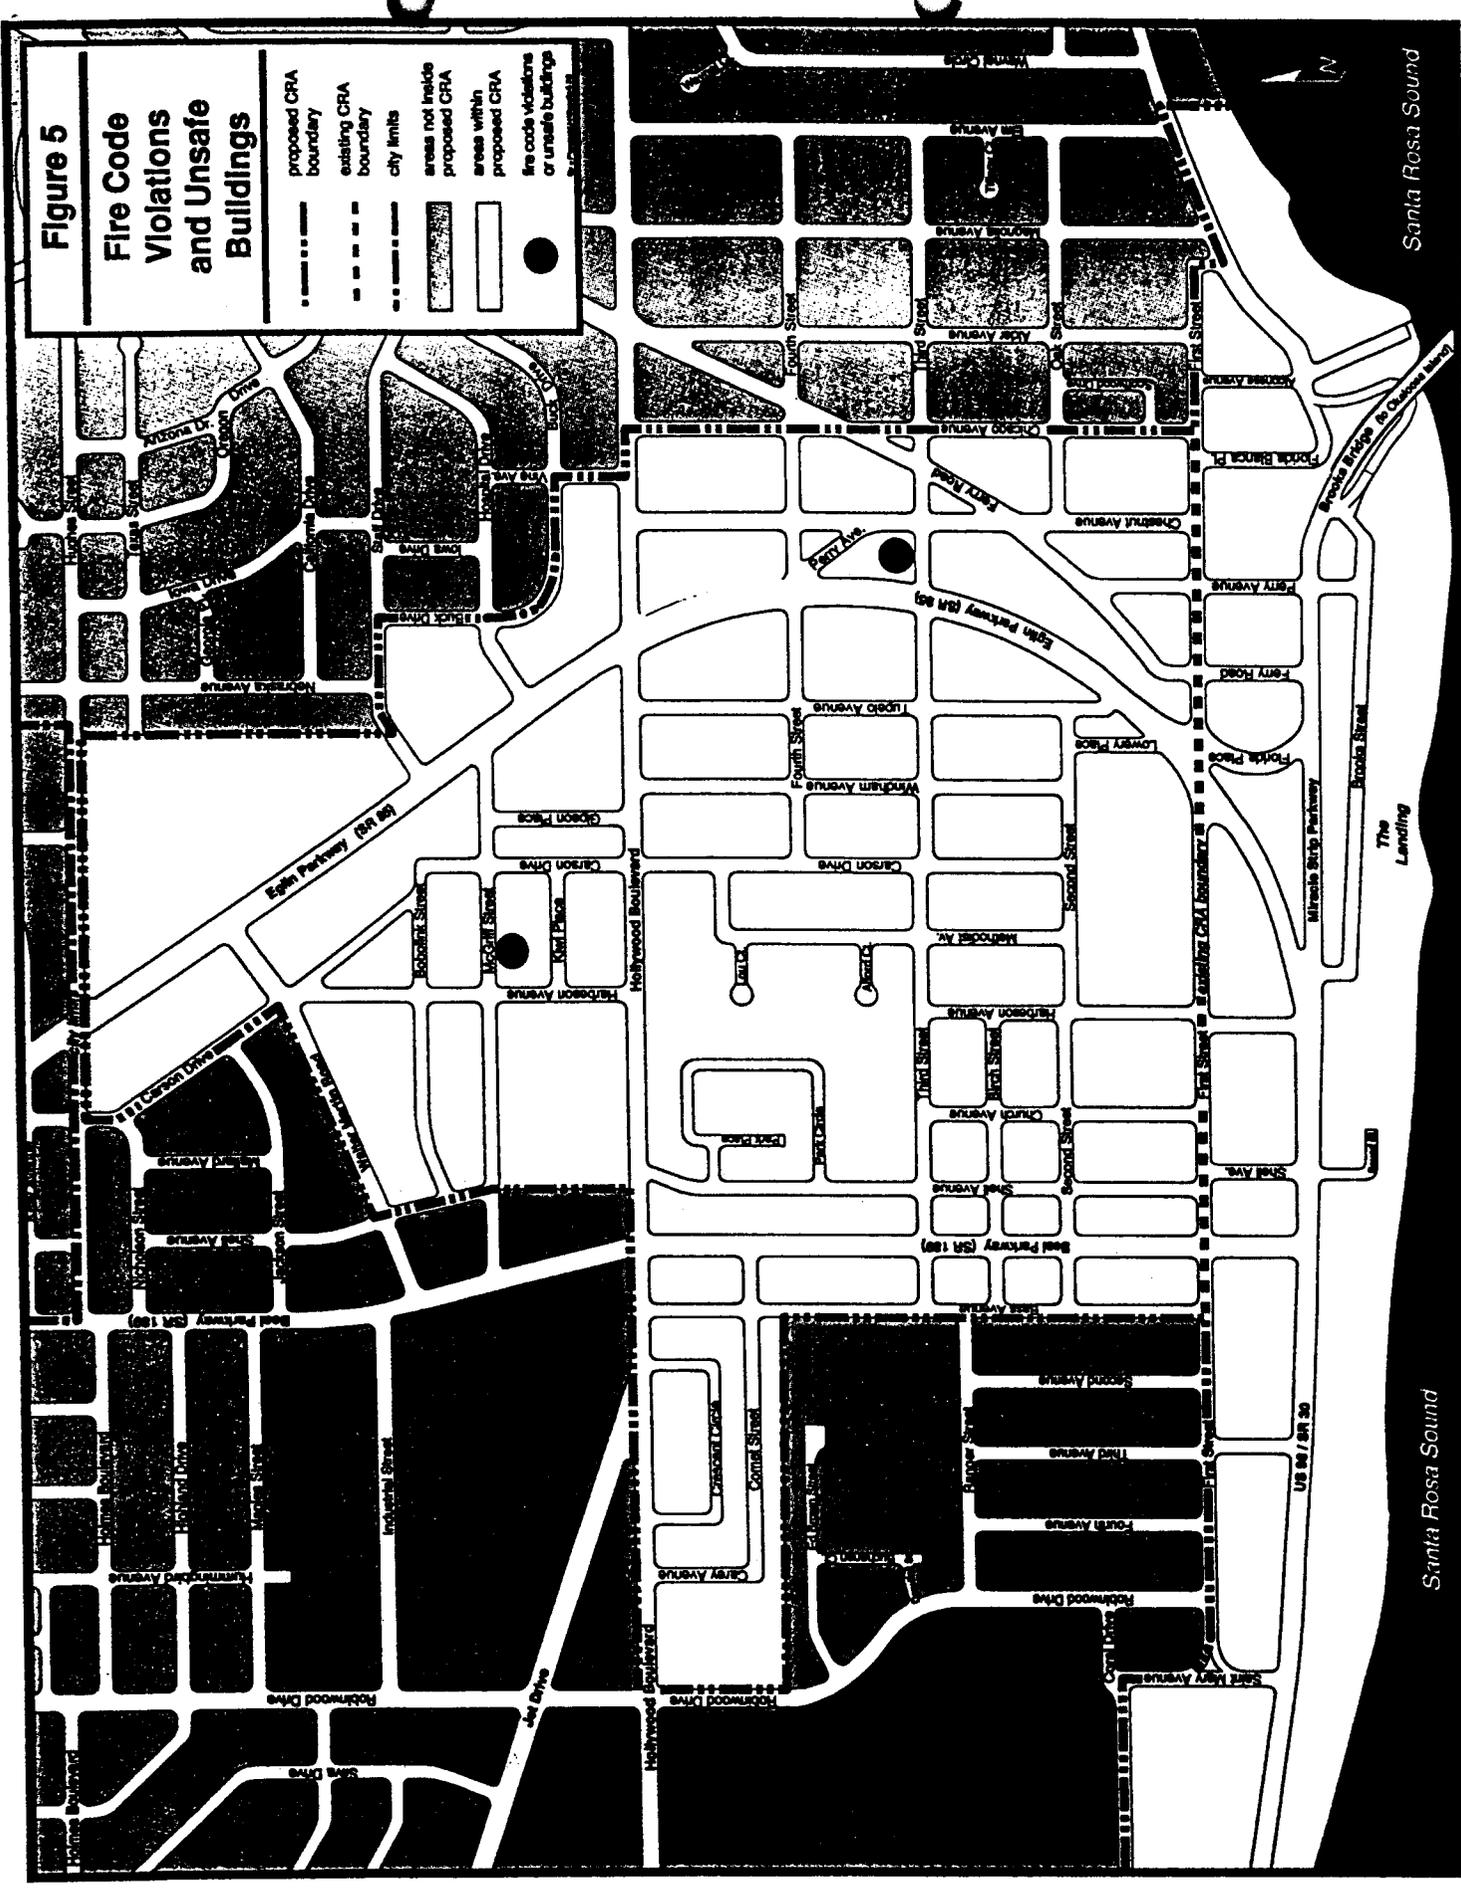
Fire Code Violations and Unsafe Buildings

There are two structures which were found to be in unsafe condition. Their locations are shown in Figure 5.

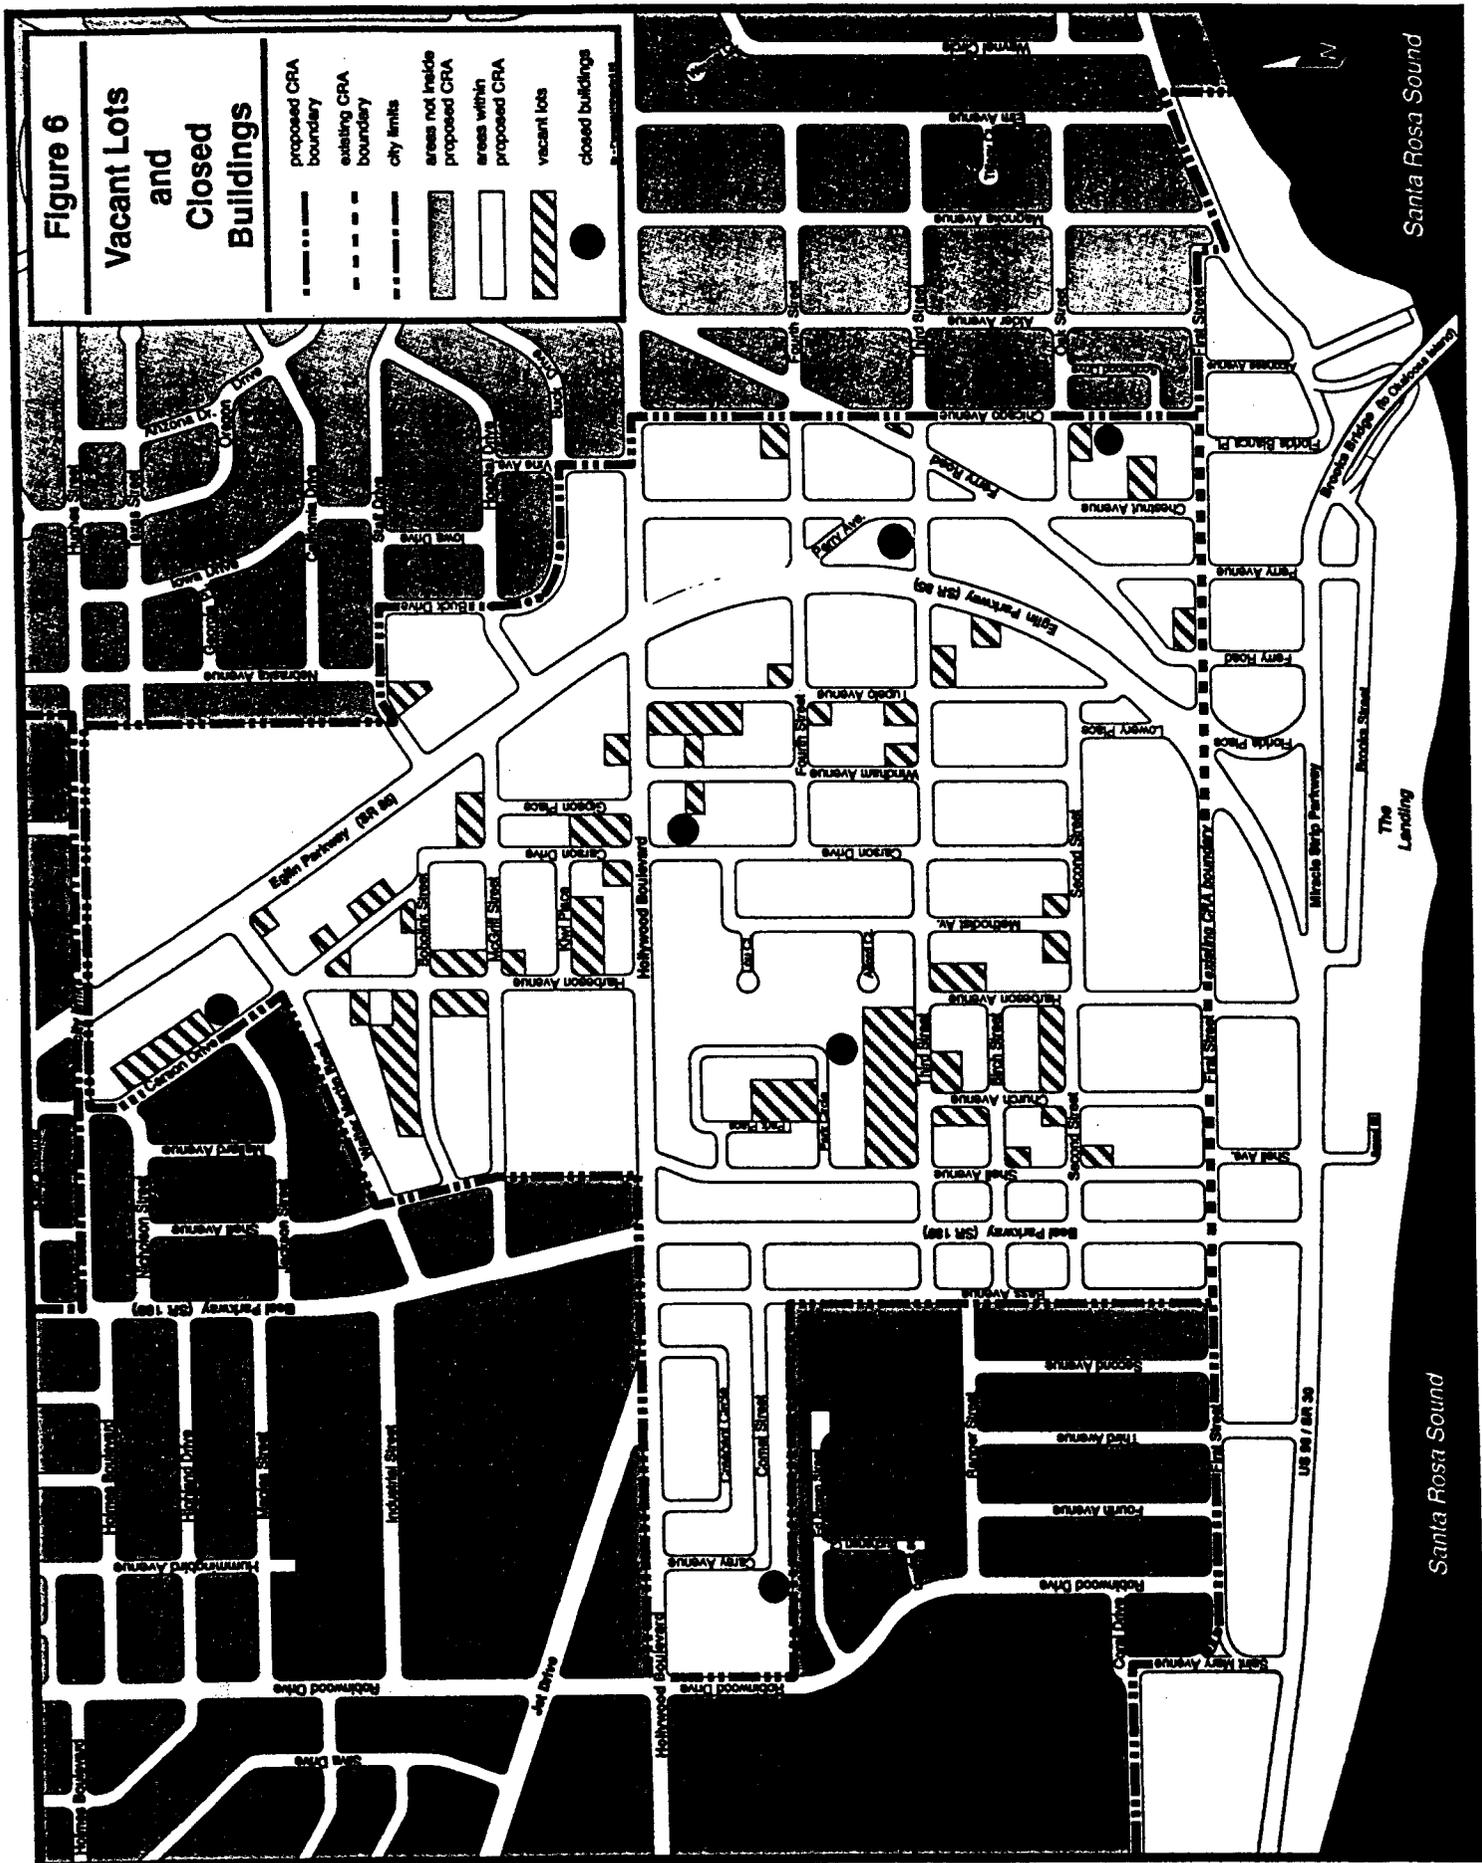
As illustrated in Figure 6, there are 44 vacant properties and 6 closed buildings in the CRA Expansion Area. Of the 44 vacant lots, several are in poor condition and presently are used for dumping. The 6 closed buildings occupy sites which collectively sum to approximately 2 acres, and the vacant lots add approximately 31.7 acres. Collectively, these vacant properties comprise 34 acres, which is 4.4% of the net developable land in the proposed CRA area.

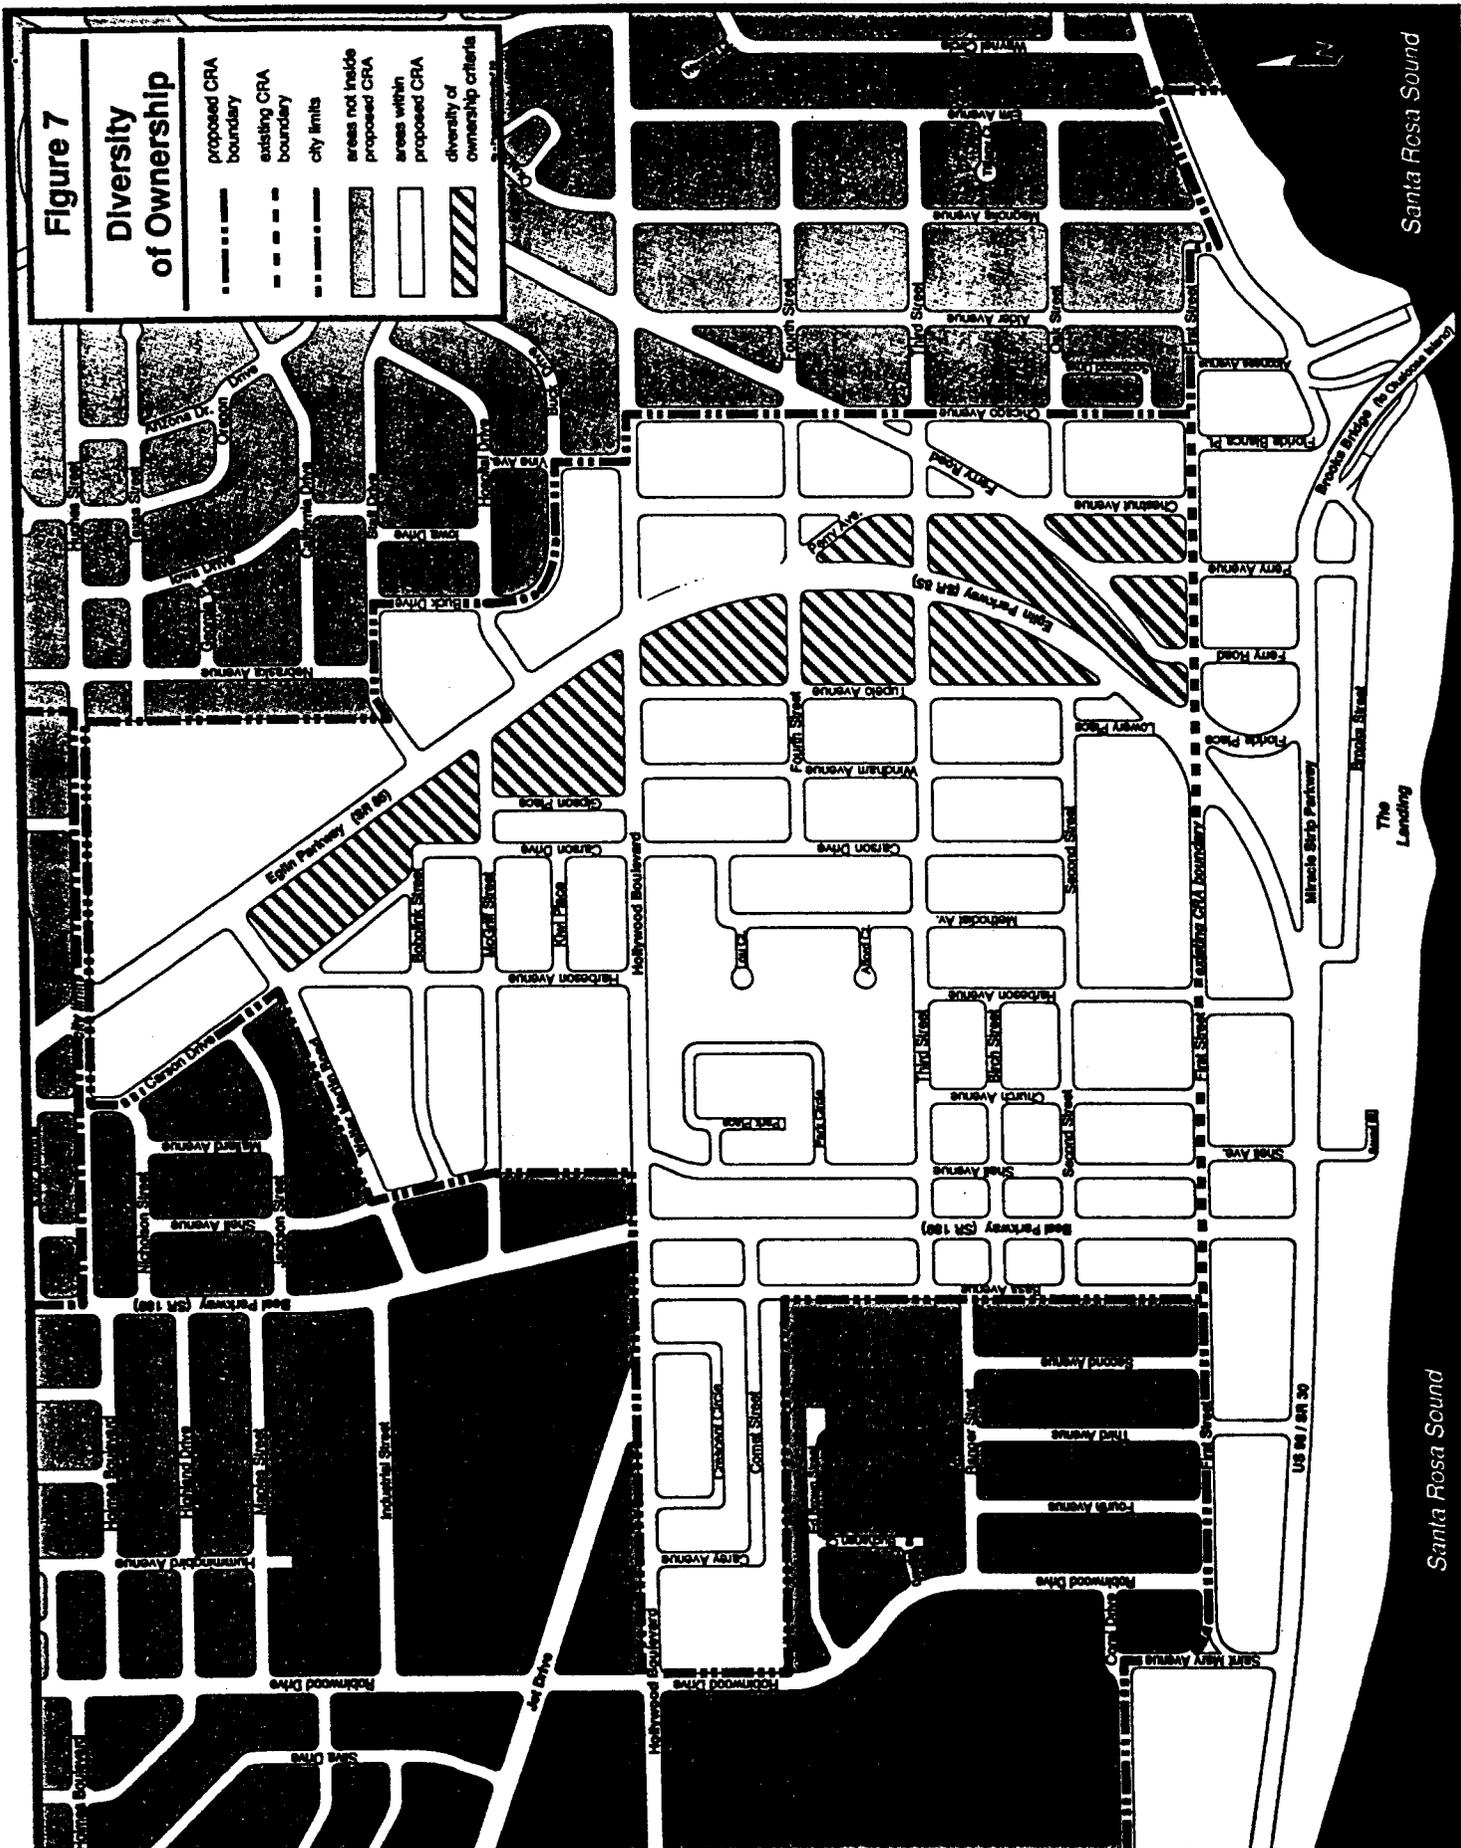
Diversity of Ownership

The blocks which were found to meet the criteria of Section 4.5.2 are shown in Figure 7. These nine blocks comprise approximately 18% of the proposed CRA area.

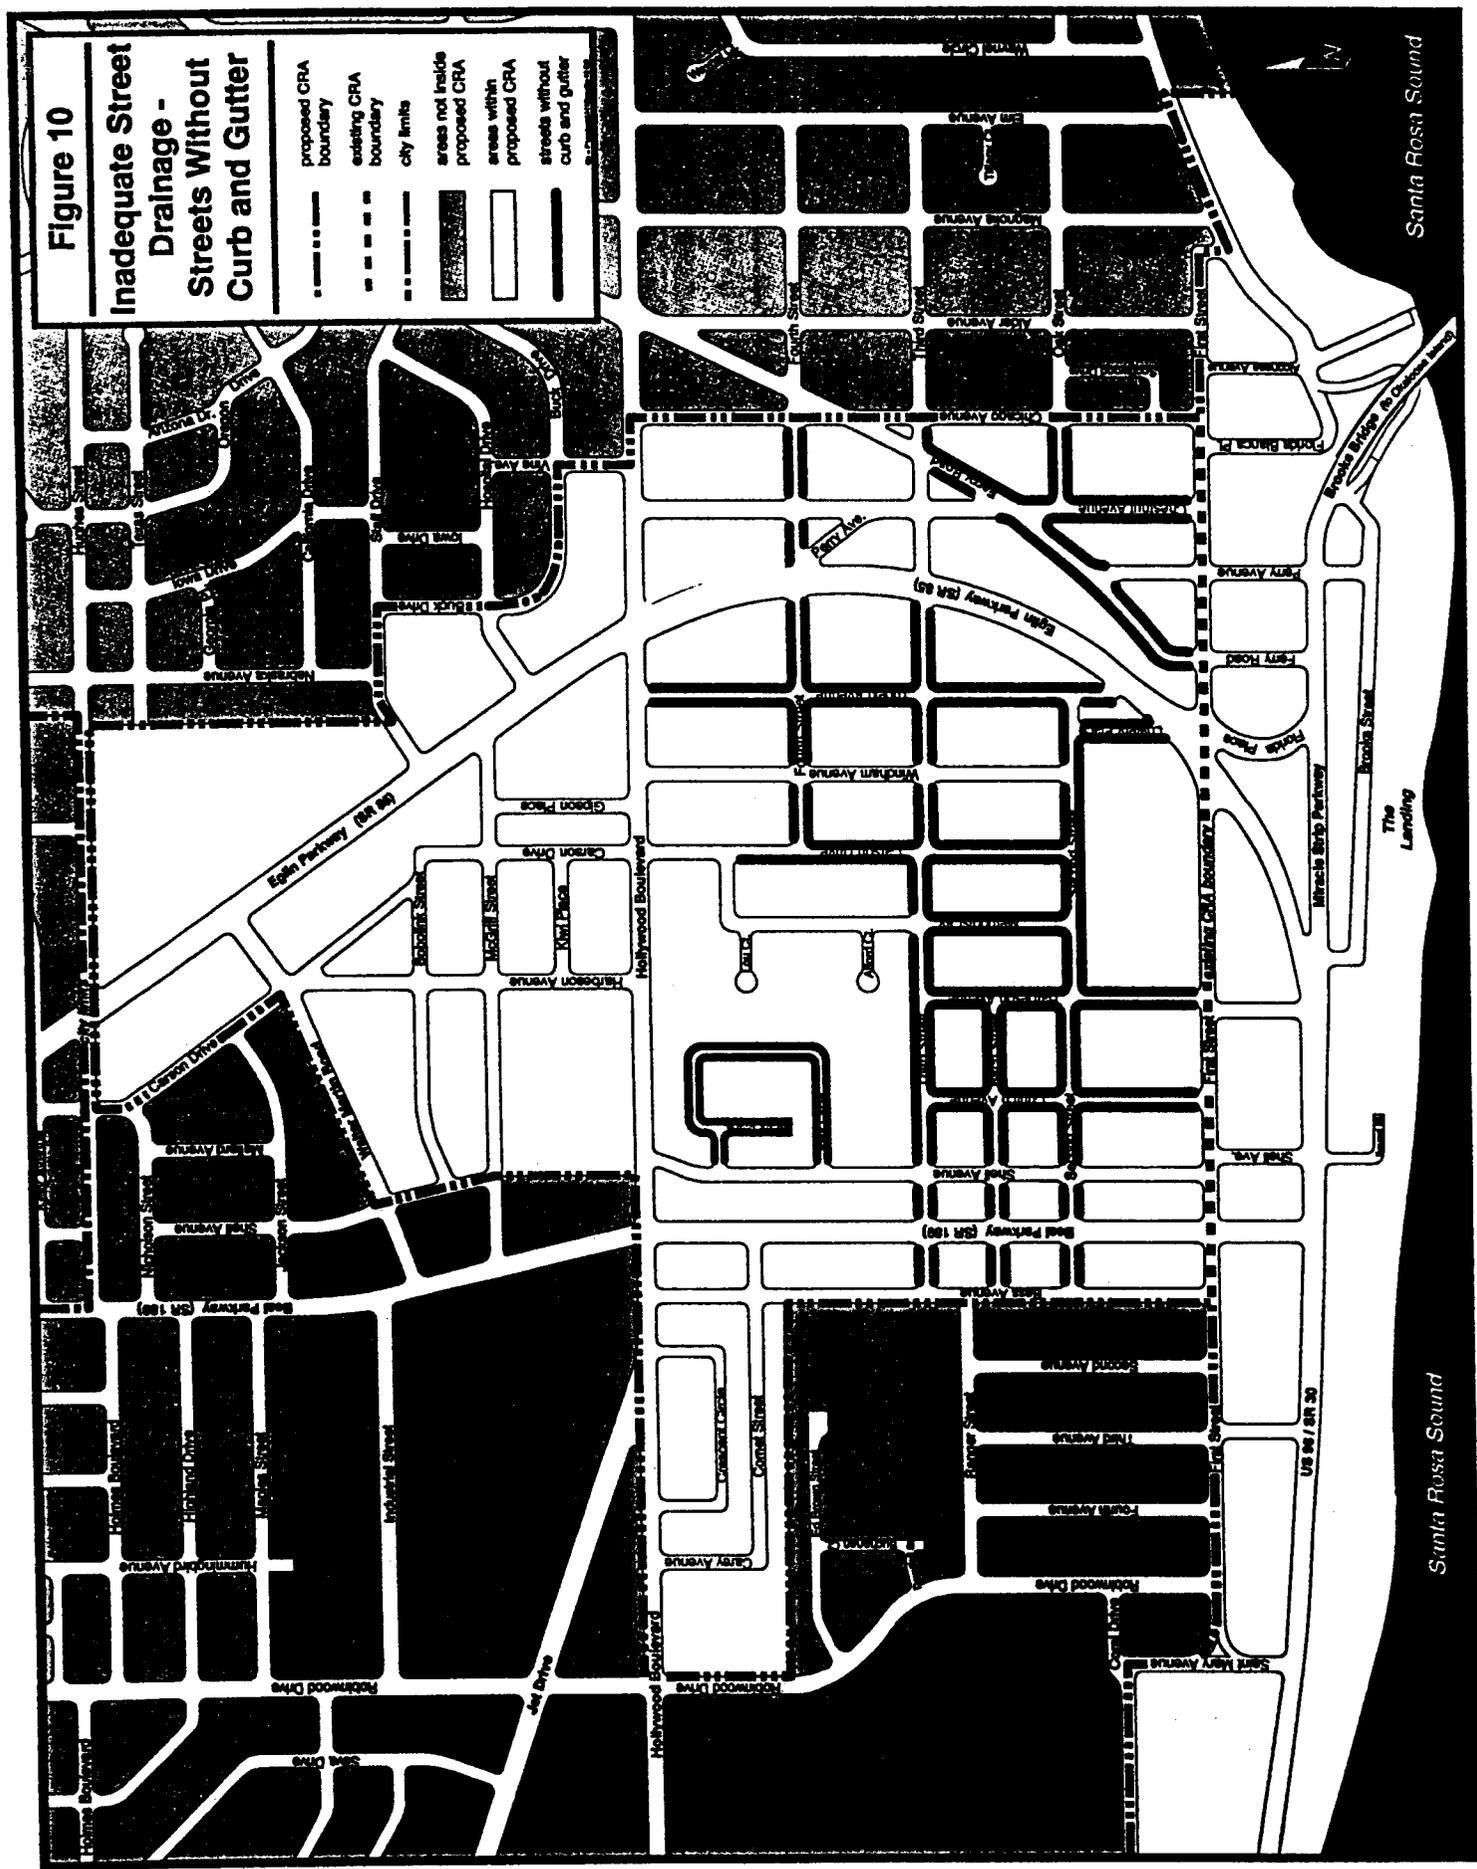
Figure 10

Inadequate Street Drainage - Streets Without Curb and Gutter

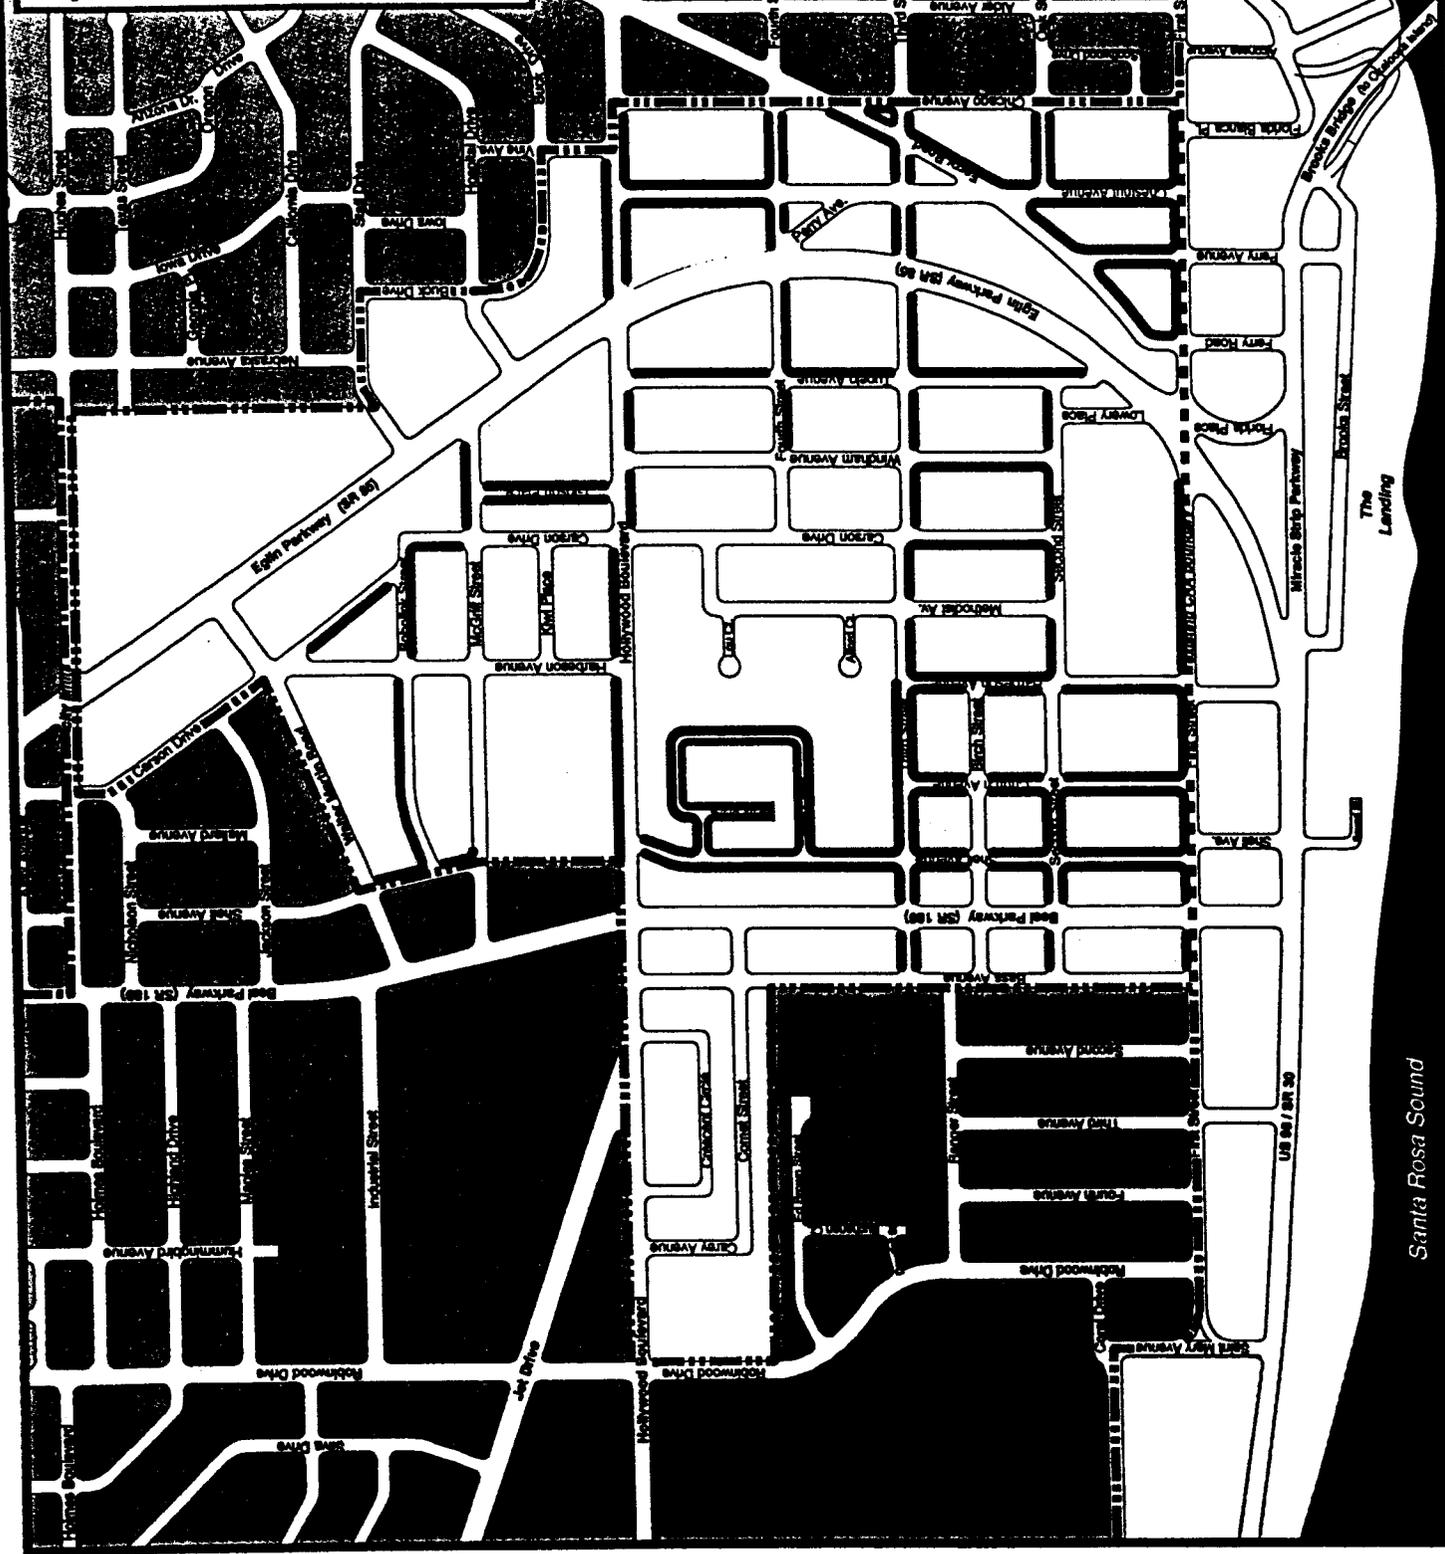
Figure 11

Inadequate Sidewalks
