Above the Flood: Elevating Your Floodprone House

FEMA 347 / May 2000

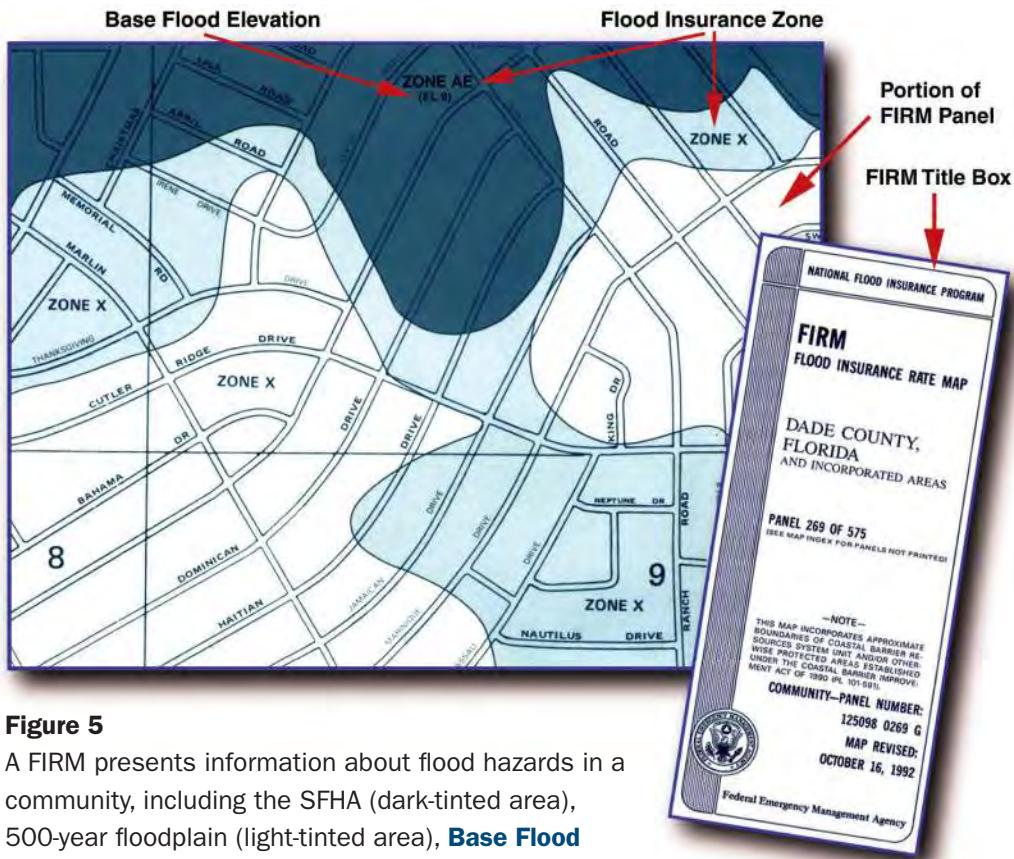
A FIRM presents information about flood hazards in a community, including the SFHA (dark-tinted area), 500-year floodplain (light-tinted area), **Base Flood Elevation** (BFEs) (number in parentheses), and flood insurance zones (AE and X in this example).

Note that the SFHA in the example in Figure 5 is designated Zone AE. This zone is only one of several applied to SFHAs under the NFIP, including V, VE, V1-V30, A, AE, A1-A30, AO, and AH. These zones indicate differences in the types and severity of flood hazards in SFHAs. For the purposes of this publication, it is sufficient to focus on the basic differences between the two main types of SFHA zones—V zones and A zones. The distinction is important because regulatory requirements associated with V zones and A zones differ significantly. As explained later in this chapter, these requirements affect the types of building elevation techniques that may be used under the NFIP.

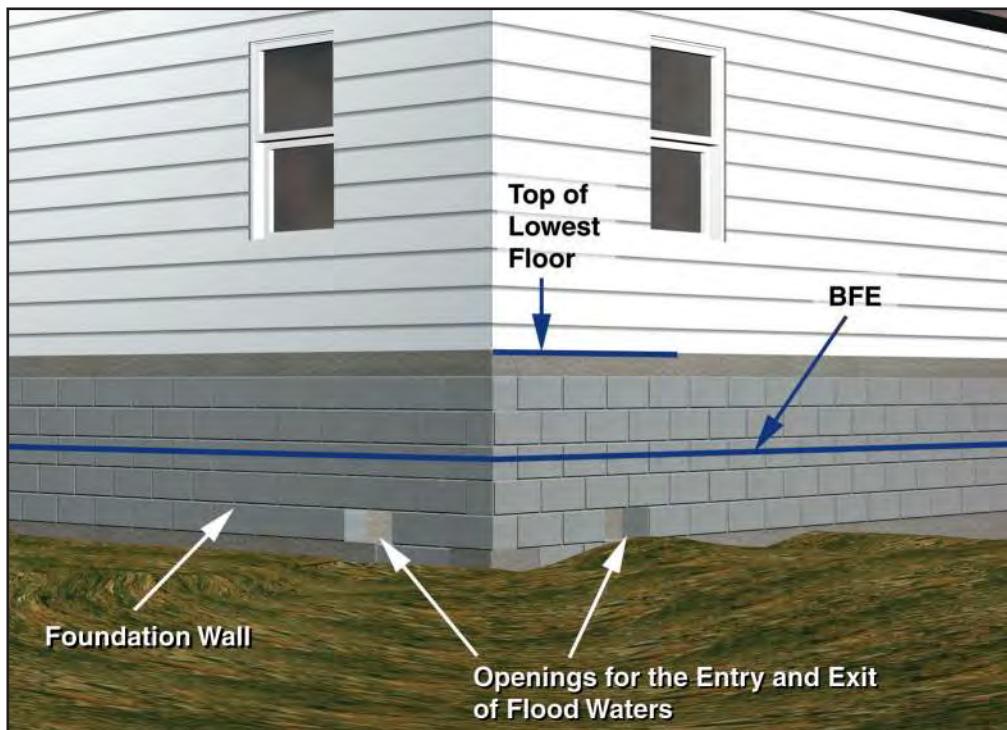
Figure 6

In a new, substantially improved, or substantially damaged building in an A zone, the elevation of the lowest floor must be at or above the BFE.

In A zones, where flood hazards are less severe, buildings may be elevated either on an open foundation or on continuous foundation walls below the BFE (Figure 6). Regardless of the type of foundation used, A-zone buildings must be elevated so that the **lowest floor** is at or above the BFE, as shown in Figure 6. If continuous walls are used below the BFE, they must be equipped with openings that allow flood waters to flow into and out of the area enclosed by the walls (Figure 6). Allowing the entry and exit of flood waters ensures that water pressures will be the same on both sides of the walls and reduces the likelihood that water pressure will cause the walls to fail.

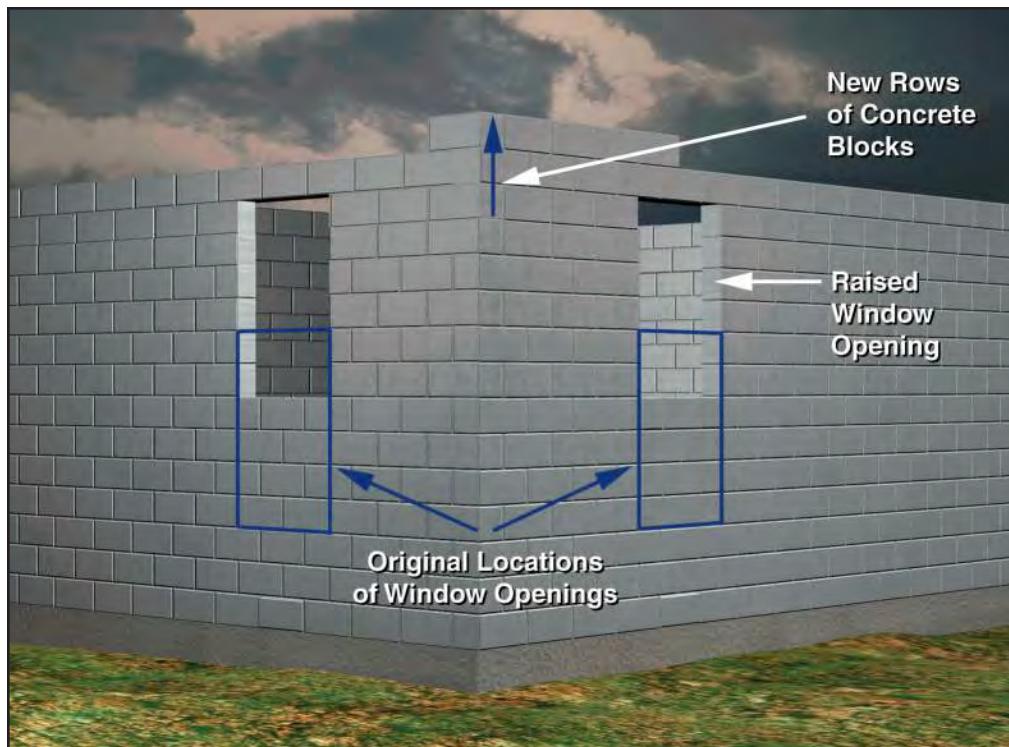
Figure 11

The tops of the walls and bottoms of the window openings are raised with concrete blocks.

After the roof, windows, and doors are removed, several courses of concrete block are added to the tops of the existing walls and to the bottoms of the window openings (Figure 11). A corresponding number of blocks are removed from the tops of the window openings so that the size of the windows will remain the same. In addition, although not shown in Figure 11, concrete bond beams are formed in place at the tops of the extended walls to provide structural reinforcement.

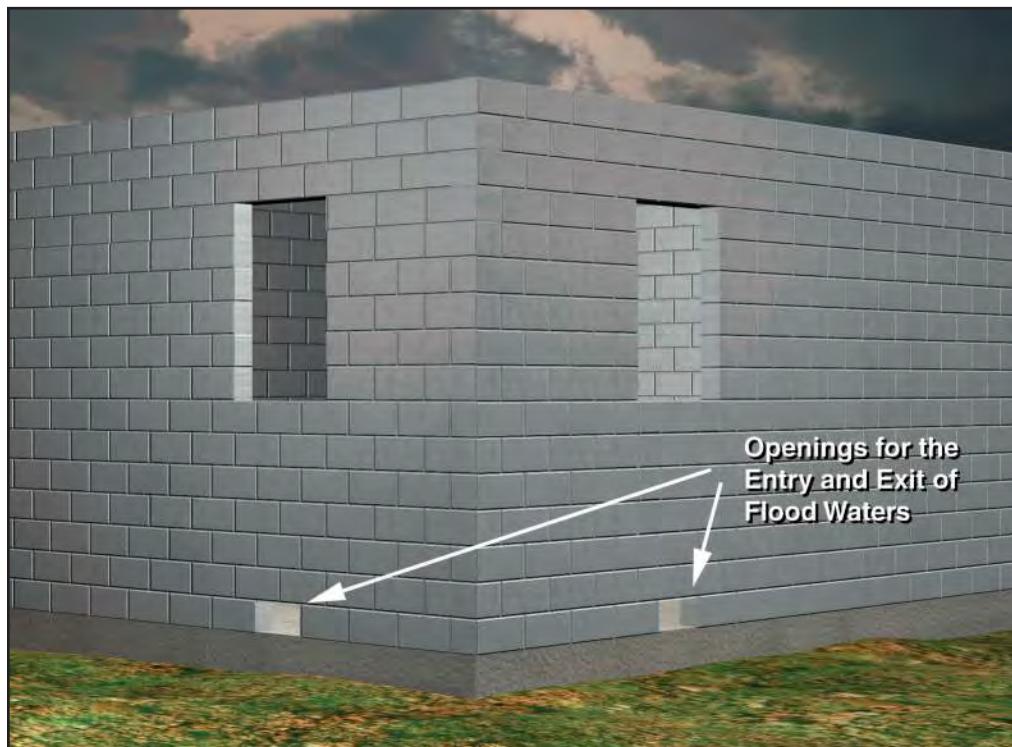
Openings are created in the walls near the ground.

Blocks are removed from the walls of the house at selected locations within 1 foot of the ground (Figure 12). The resulting openings will allow flood waters to flow into and out of the lower area of the house so that the water pressures on both sides of the walls will remain the same. The roof and windows are then replaced, and a new wood-frame floor is constructed above the flood level (Figure 13).

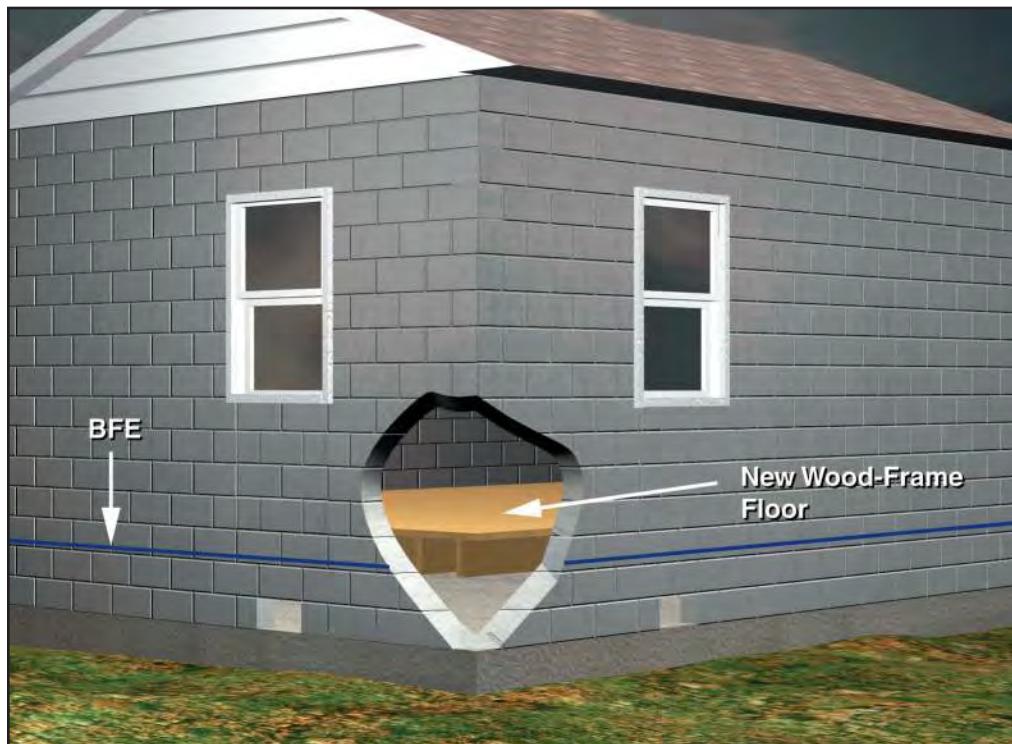
**Figure 13**

A new wood-frame lowest floor is constructed above the flood level, and the roof, windows, and doors are reinstated.

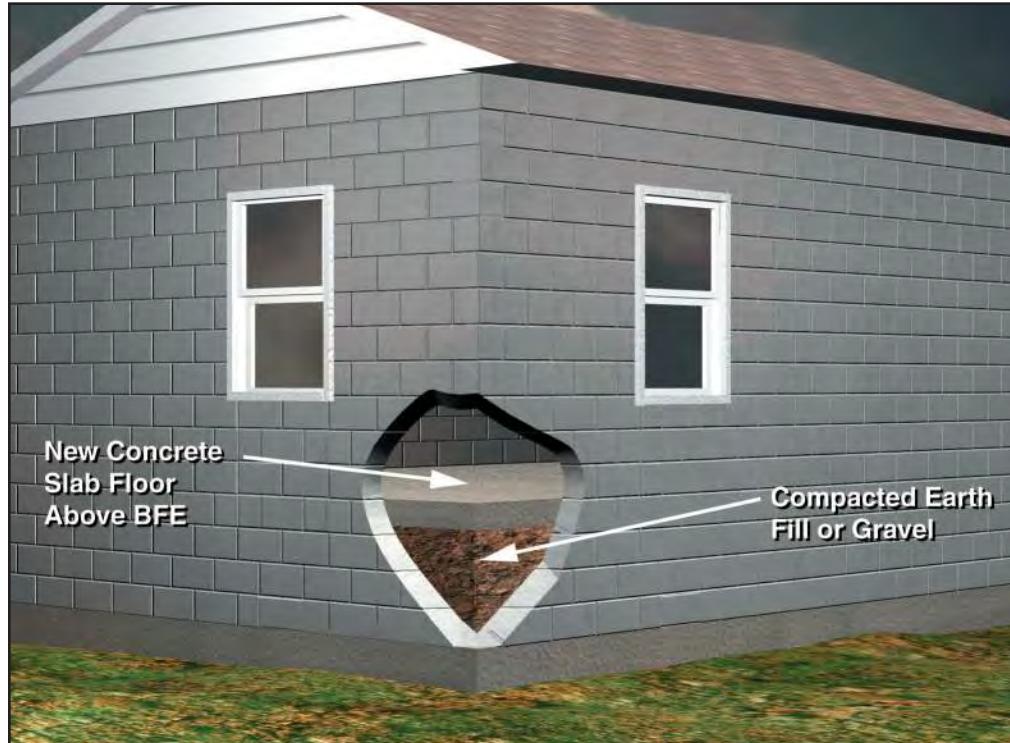
Figure 14
An alternative to building an elevated wood-frame floor is installing a new, elevated concrete slab floor on fill placed over the old slab.

A homeowner who chooses Technique 1 may decide to build a new concrete slab floor instead of a wood floor (Figure 14). When this option is chosen, compacted fill dirt or gravel is placed on top of the old slab and the new slab floor is poured on top. Because the area below the new floor is filled with dirt or gravel, wall openings are not required.

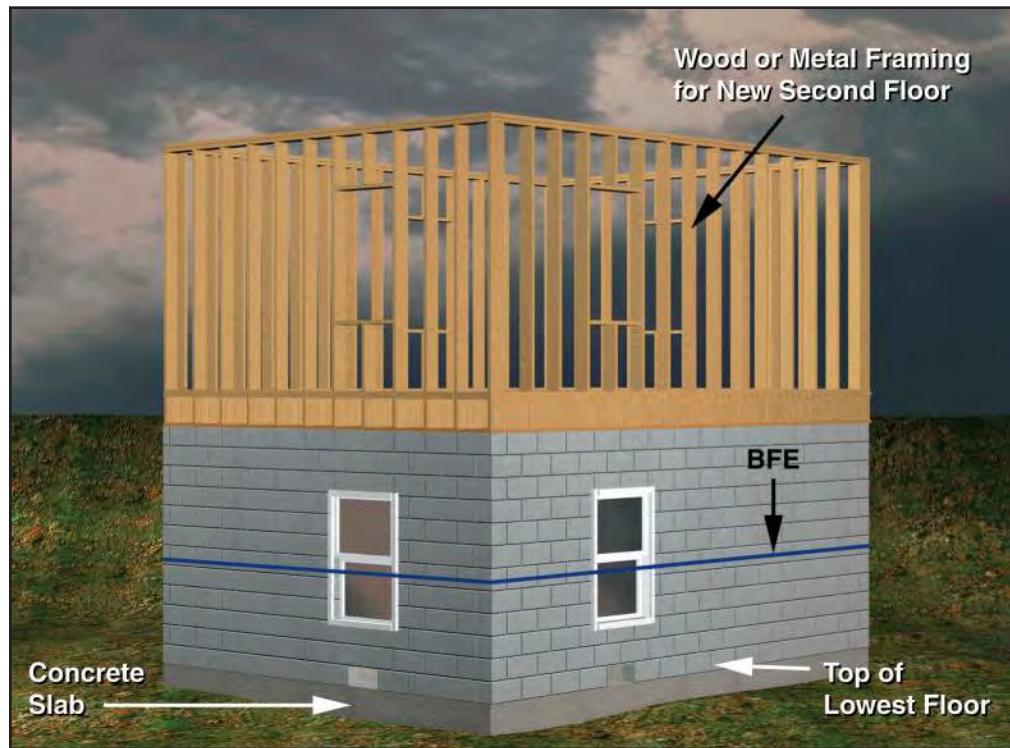
The new second-story floor and walls are built on top of the existing lower story.

As in Technique 1, the repairs begin with the temporary removal of the roof and roof framing (Figure 10). After the roof is removed, construction of the new second story begins. First, a new wood-frame floor is built on top of the existing lower-story walls. The second-story walls are framed with metal or wood studs and set in place on the floor (Figure 15).

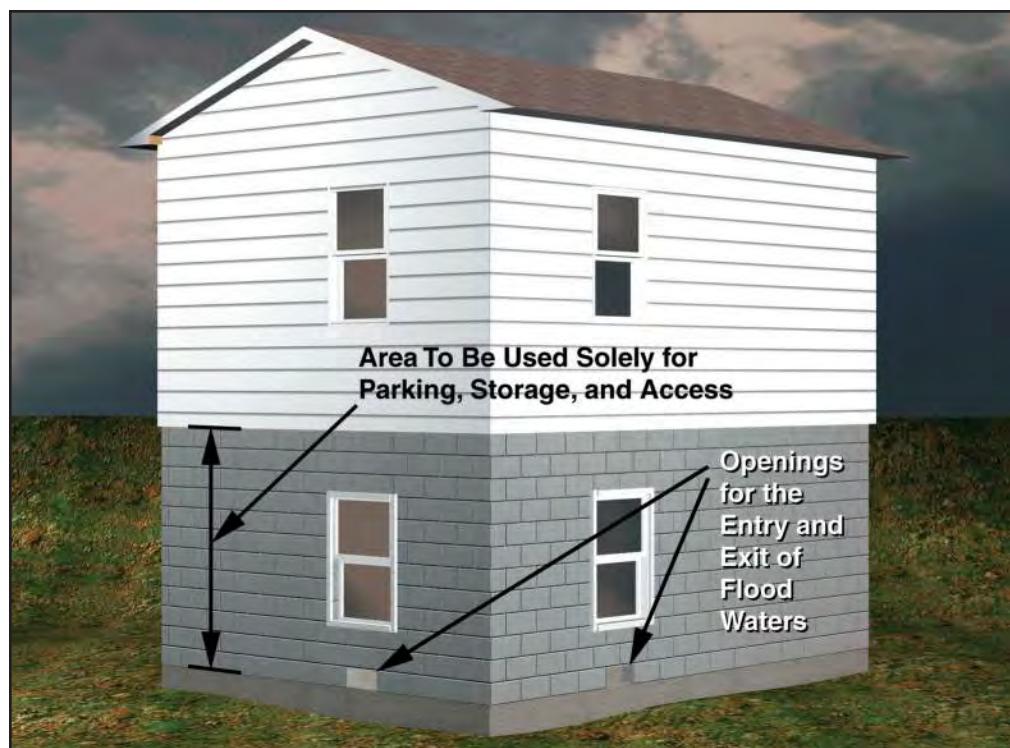
The new second-story walls are covered with siding or stucco.

Some homeowners prefer that the second story be constructed of masonry, but wood- or metal-framing is more common, primarily because it is lighter and less expensive. The roof is replaced, and blocks are removed from the walls to allow flood waters to enter and exit. Exterior sheathing is then added to the framed walls of the second story, the new windows are installed, and siding or stucco is applied to the sheathing (Figure 16).

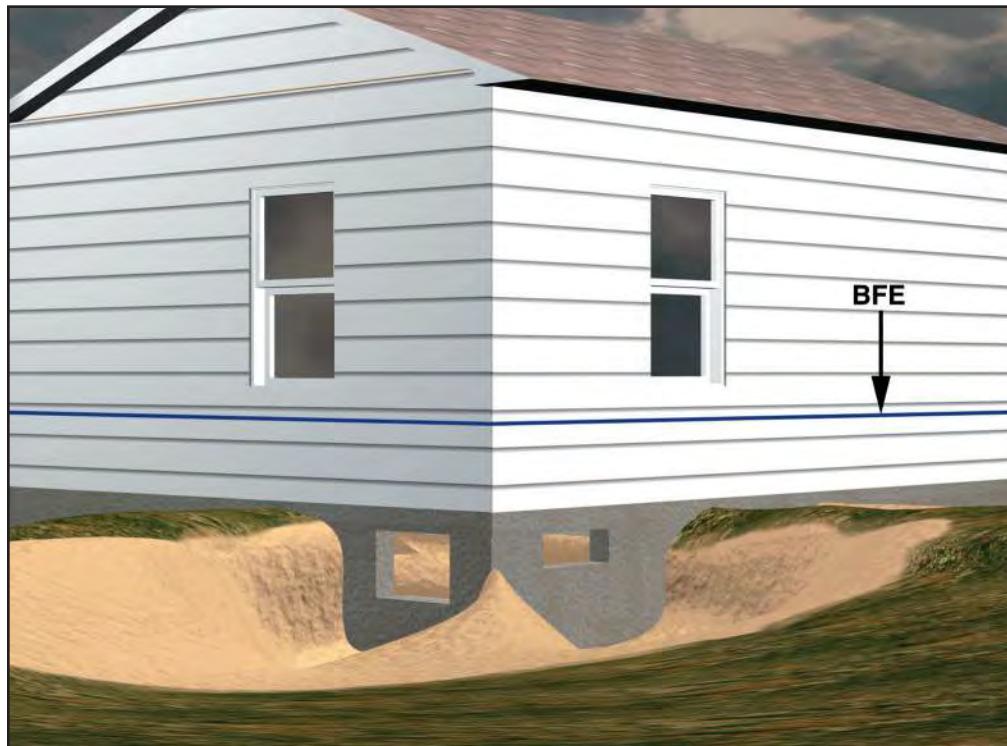
Figure 17
Trenches and tunnels under the slab provide access for the jacks and I-beams that will lift the house.

First, trenches are dug to expose the foundation walls immediately below the slab. Holes are then cut in the foundation walls at intervals around the house, and tunnels are dug under the slab (Figure 17). Jacks are placed in the trenches and large I-beams are inserted through the tunnels and allowed to rest on the jacks. Smaller I-beams are then inserted through the tunnels at right angles to the larger beams and positioned on top of them. The smaller beams support the slab when the house is raised (Figure 18).

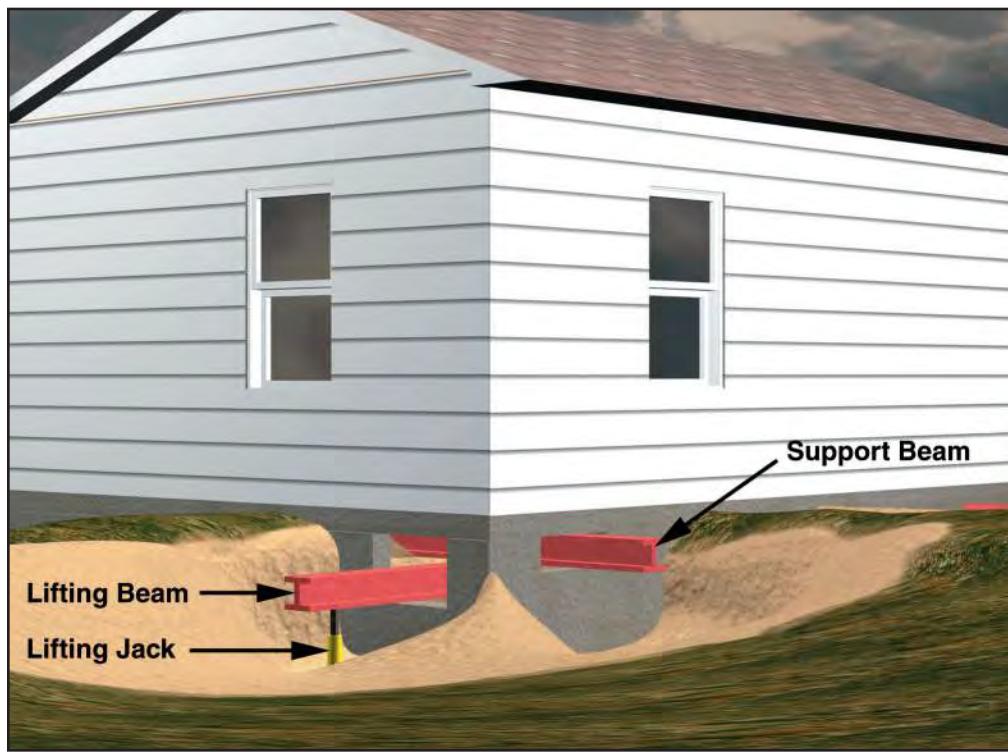
Figure 18

With I-beams and jacks in place, the house is ready to be lifted.

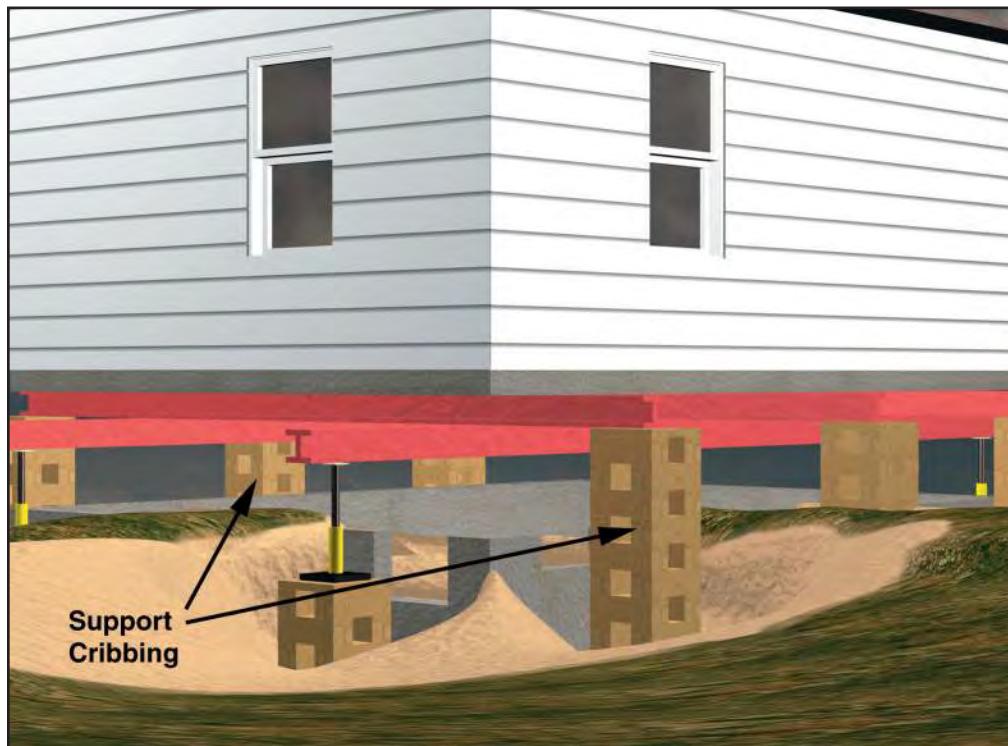
The house is temporarily supported on cribbing.

The house is then jacked up. When the jacks have extended as far as possible, the house must be supported temporarily while the jacks are raised. Both the house and the jacks are usually supported on “cribbing”—temporary piles of crisscrossed timbers (Figure 19). The jacks are then used to raise the house higher.

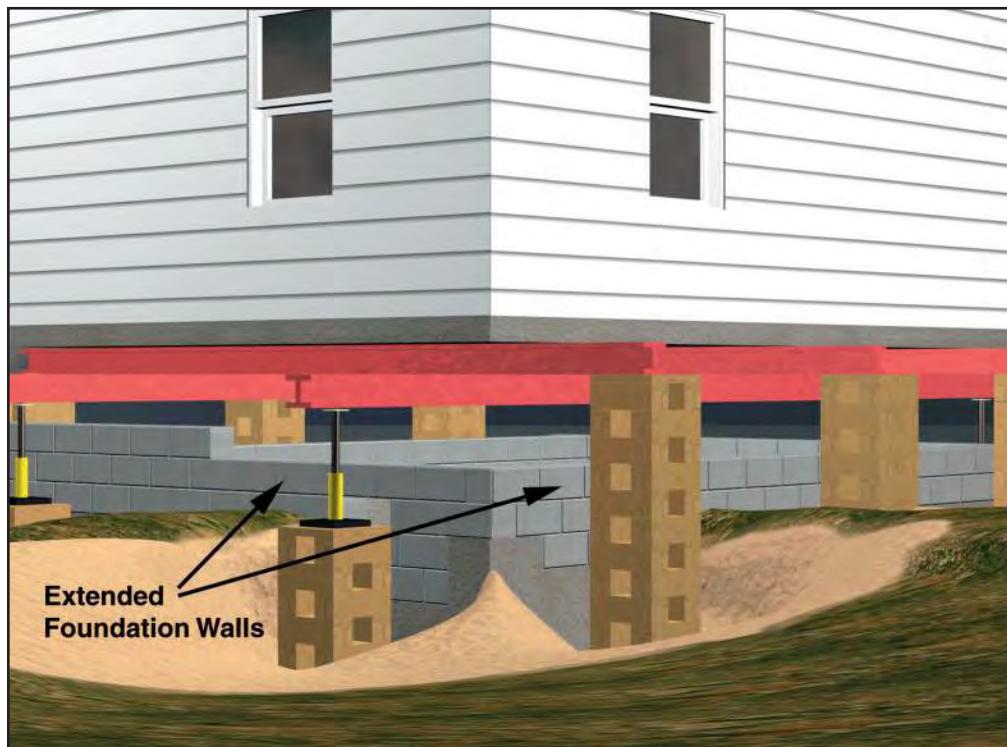
Figure 20
New, extended foundation walls are constructed with concrete blocks.

This process is repeated until the house is raised to the desired height. The foundation walls are then extended upward with additional rows of concrete block (Figure 20). As in the previous techniques, openings are made in the walls within 1 foot of the ground so that flood waters will be able to flow into and out of the area below the elevated floor. The jacks and beams are removed, and the openings left around the beams are filled with blocks (Figure 21).

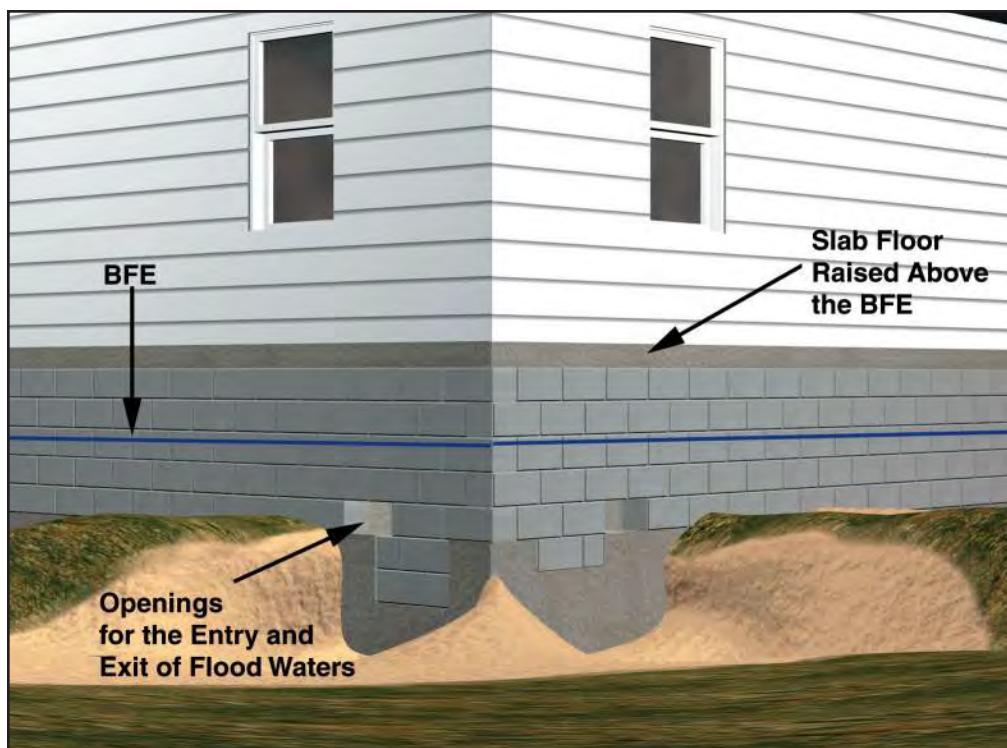
Figure 21
Elevated house and slab on new, extended foundation walls.

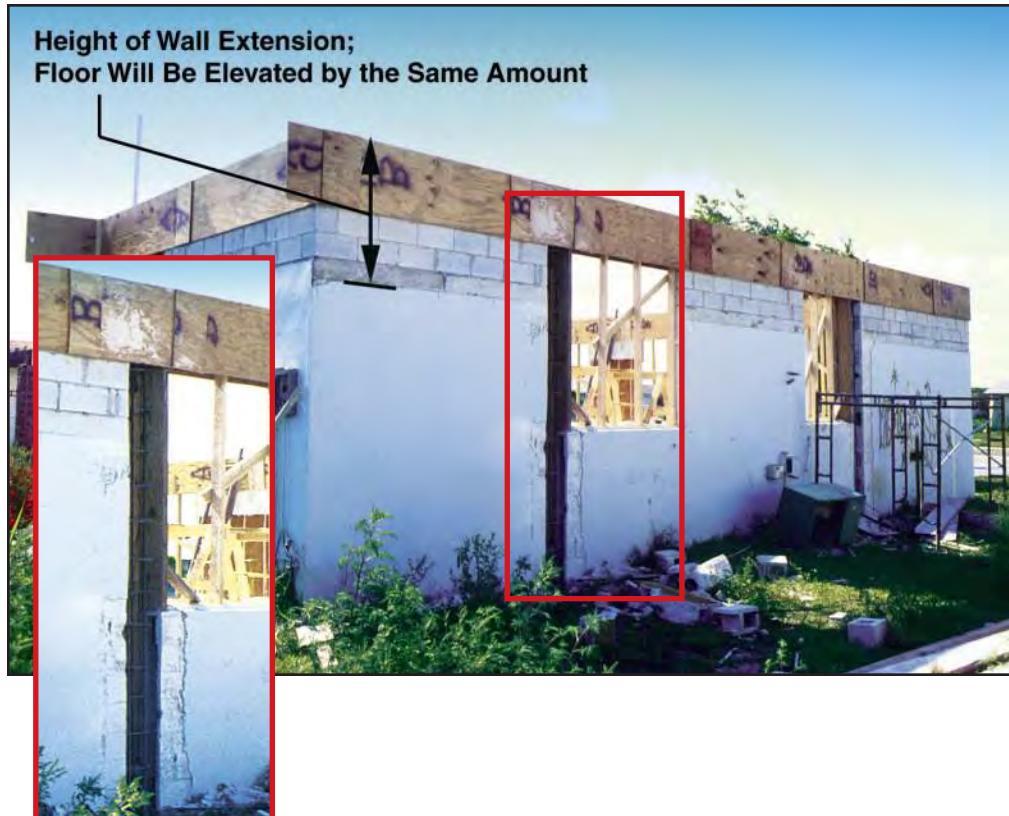
Another view of the extended walls. The vertical cuts in the walls next to the windows are for concrete tiedown columns that will be cast in place to further strengthen the extended walls against wind loads. The owner of this house was able to meet the elevation requirement by raising the floor only a few feet, as indicated by the amount that the walls have been extended.

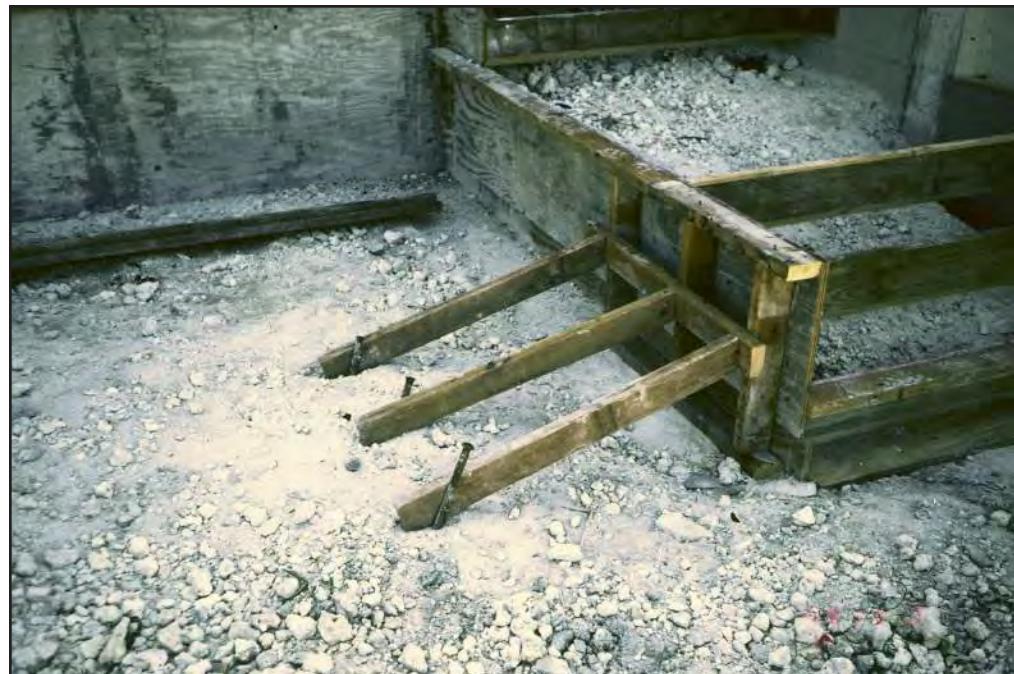
Figure 33
Wood framing for a new concrete staircase that will provide access to the elevated floor.

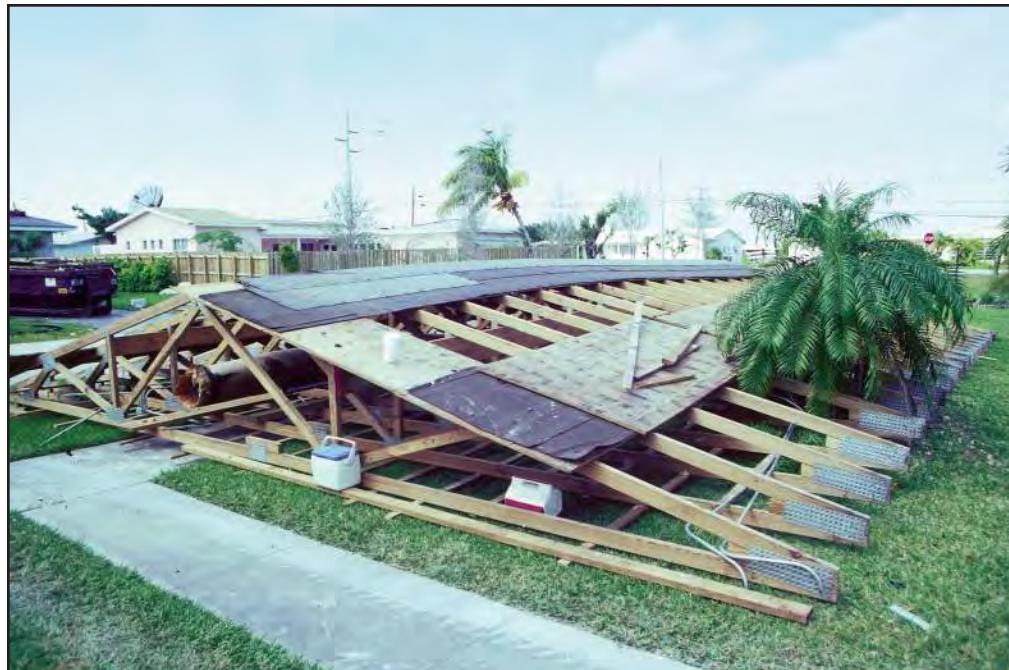
The roof of this house was removed as a single piece; the trusses were held together with bracing and portions of the original roof sheathing. This approach made it easier to reinstall the roof at the end of the project.

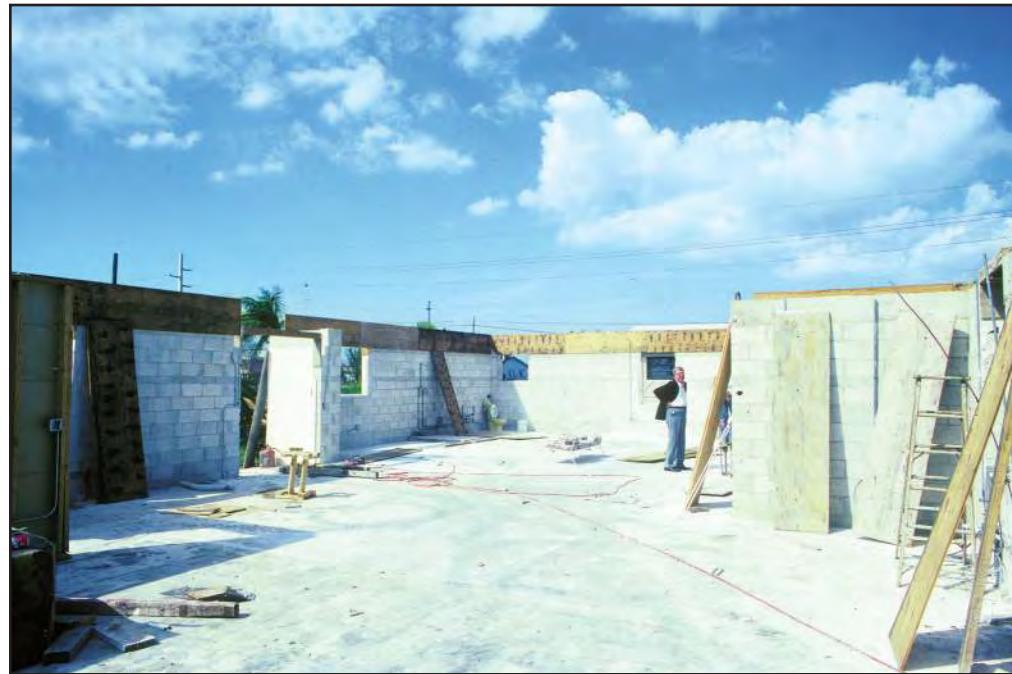
Figure 40

After the roof was removed and the storm-damaged interior gutted, the walls of the house were extended upward and a new bond beam added at the top.

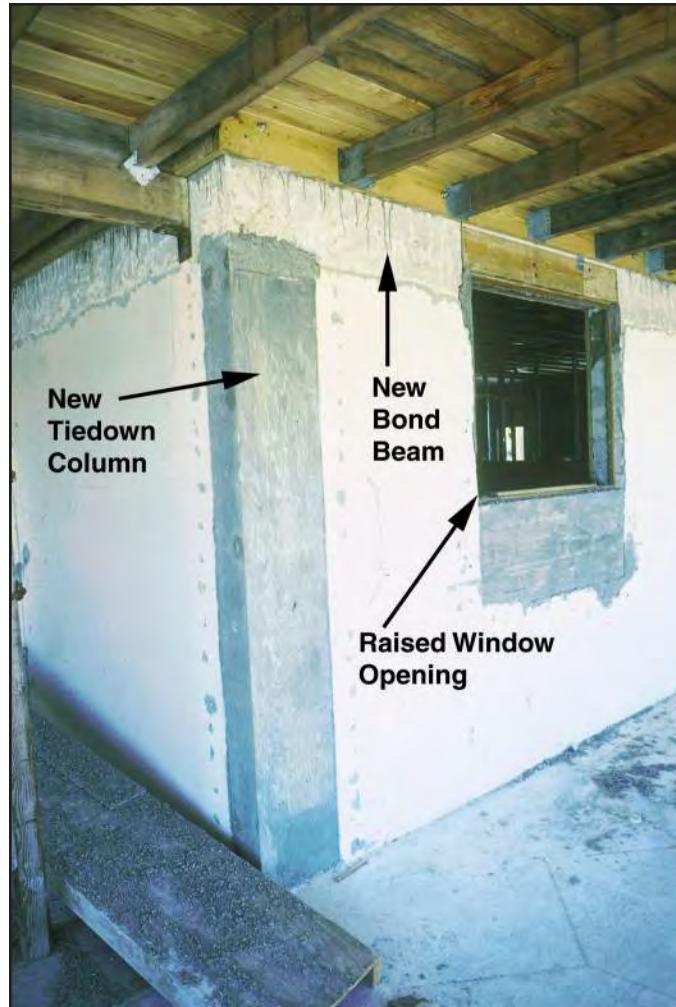
**Figure 41**

Note the new bond beam at the top of the extended wall, the new concrete tiedown column at the corner, and the raised window opening.

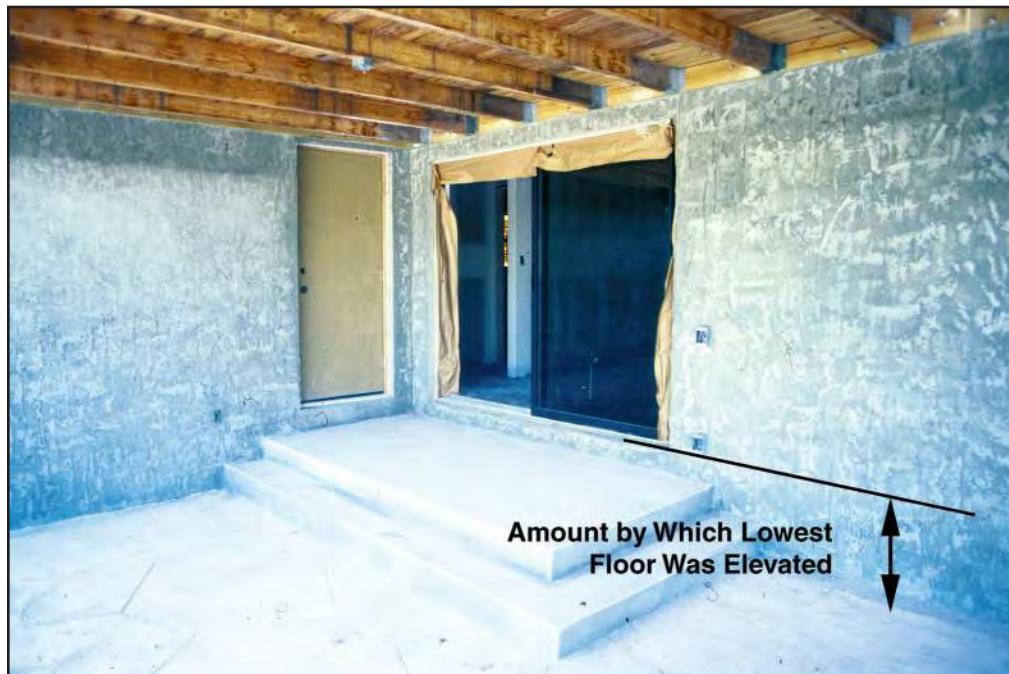
Figure 42

This view from the back of the house shows the height of the elevated slab floor.

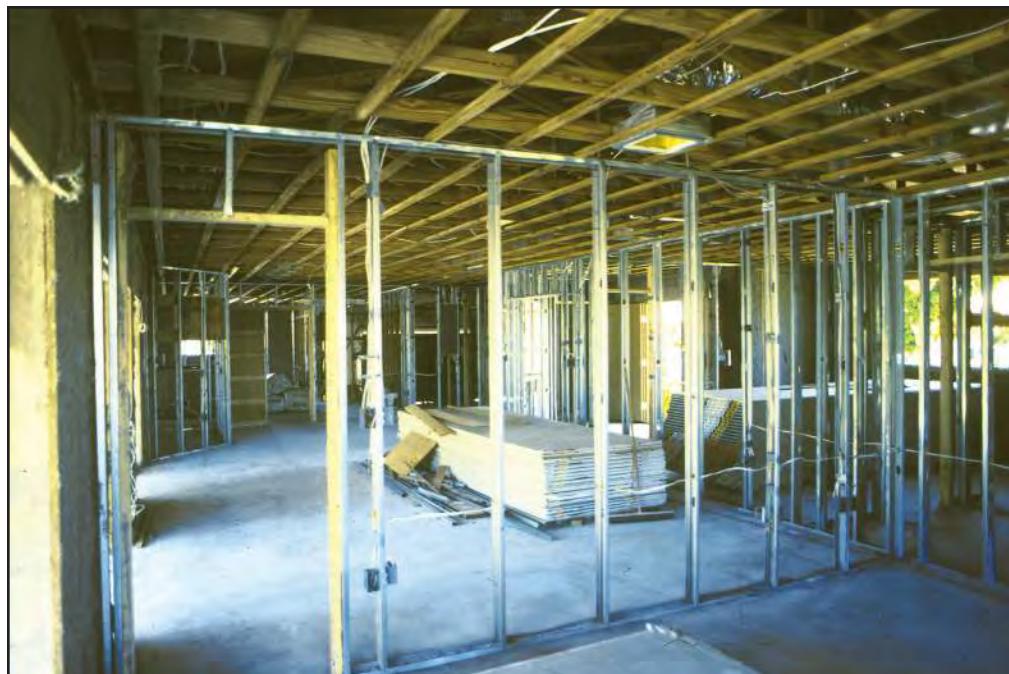
**Figure 43**

The owner of this house decided to use light-gauge metal framing for the new interior walls.

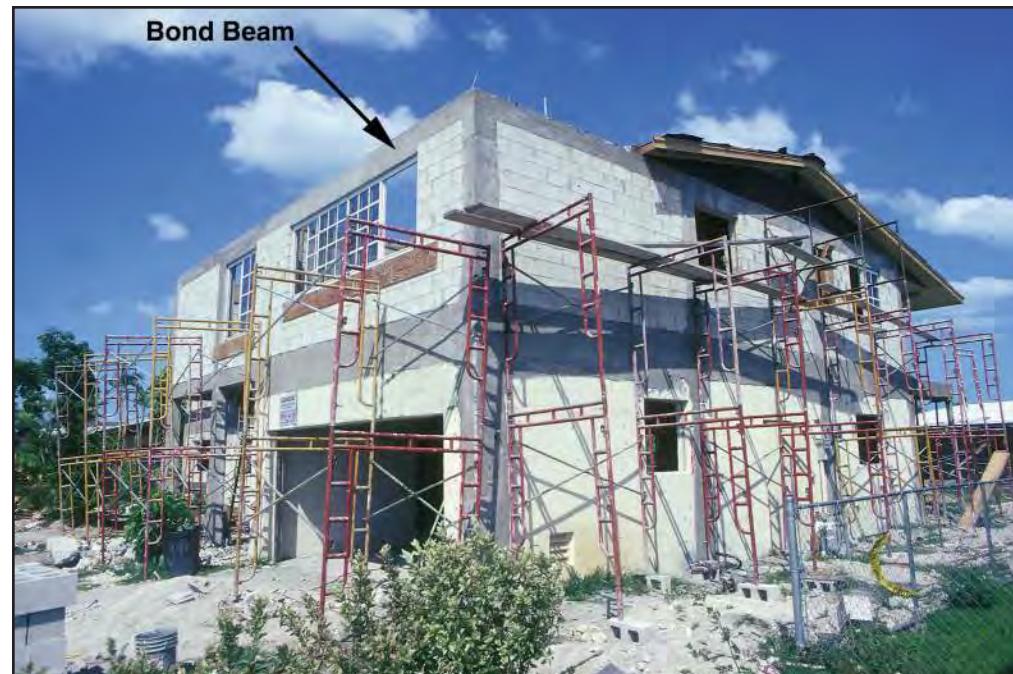
Concrete bond beams similar to those shown earlier were used in this house, but here they were installed on the tops of both the original first-story walls and the new reinforced concrete block second-story walls.

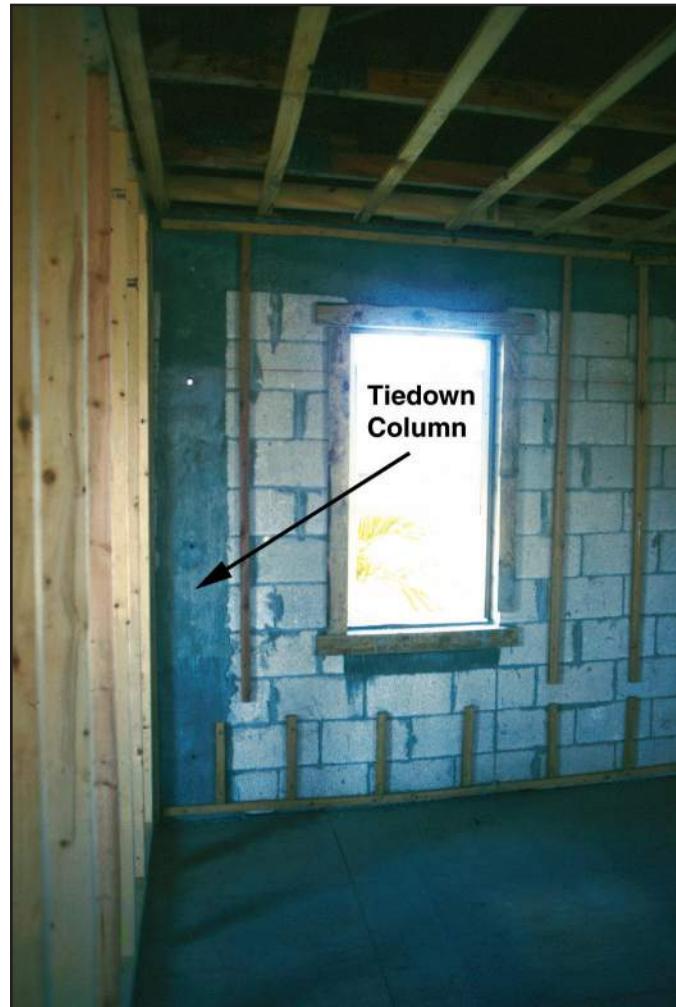
Figure 46
Concrete tiedown
columns, such as the one
to the left of the window
in this photograph, were
also used in this house.

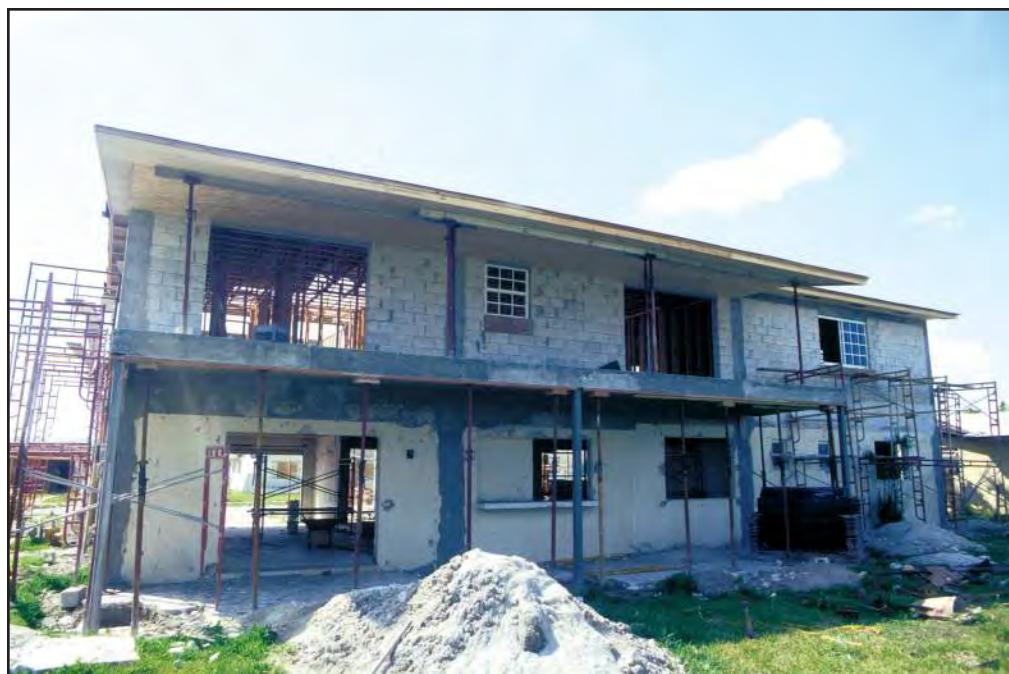
Figure 47
The tiedown columns
extend down from
the new second-story
walls and into the
original first-floor
walls. The columns tie
the first and second
stories together and
provide a continuous
load path that helps
the house resist the
forces of high winds.

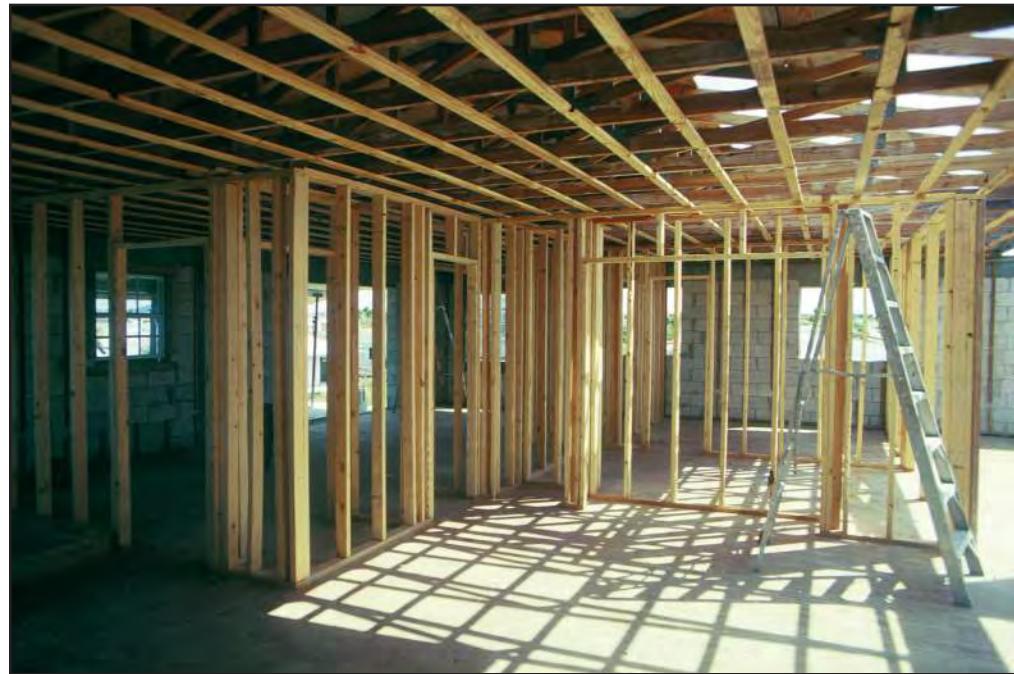
Figure 48

Wood 2 by 4 studs were used to frame the interior walls of the second story.

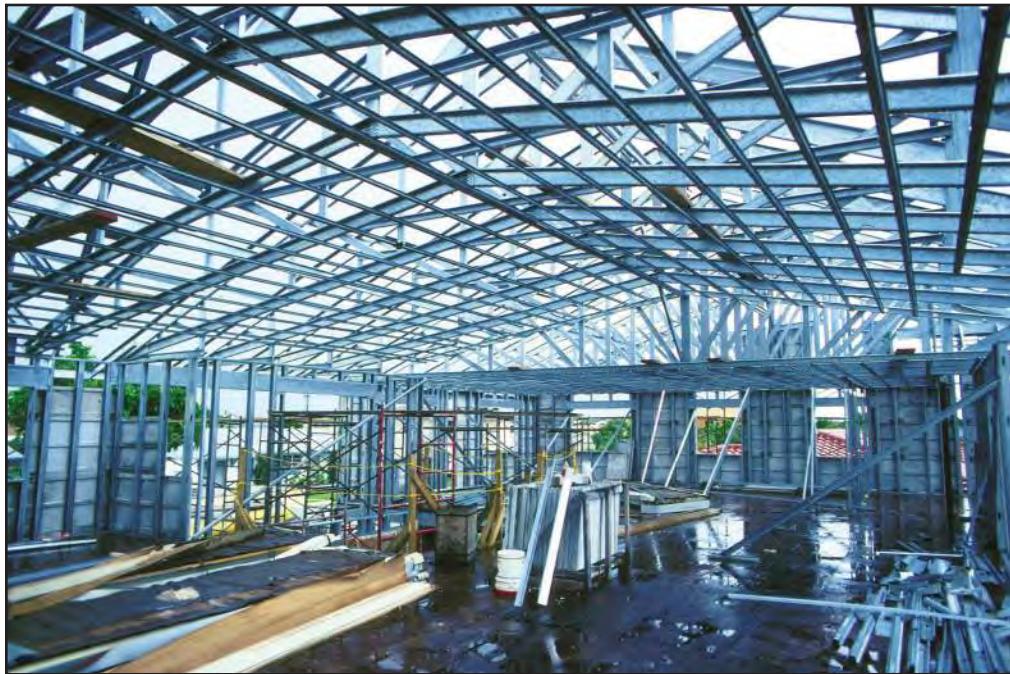
Metal framing is used for the new second story, including the walls and roof support system.

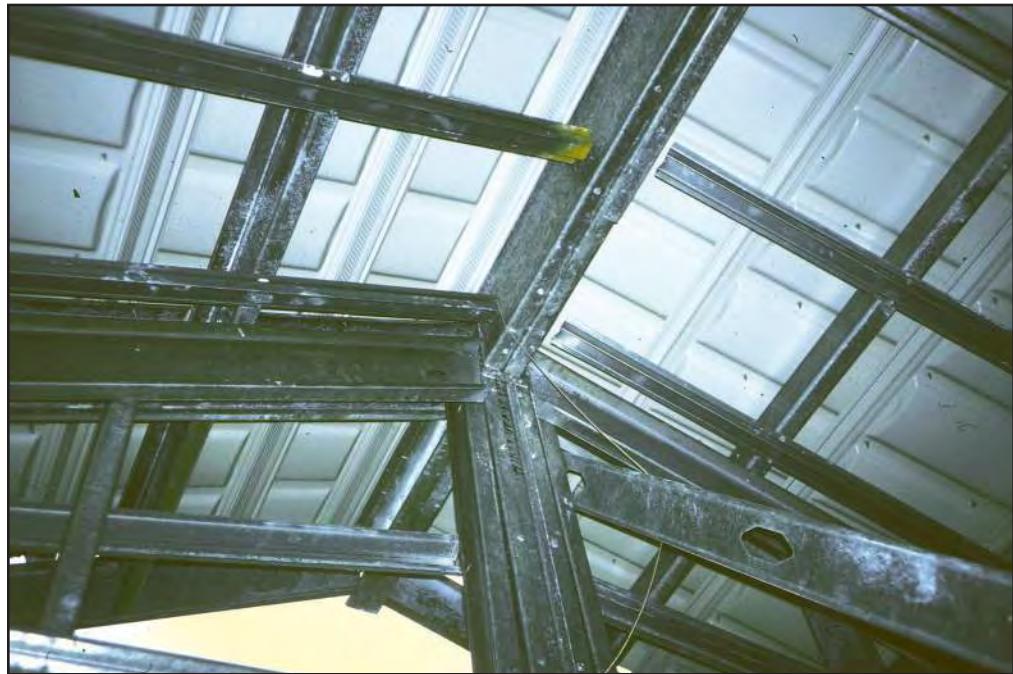
One advantage of metal framing is its relatively light weight. An additional advantage is that the screws used to attach metal-frame components provide strong connections.

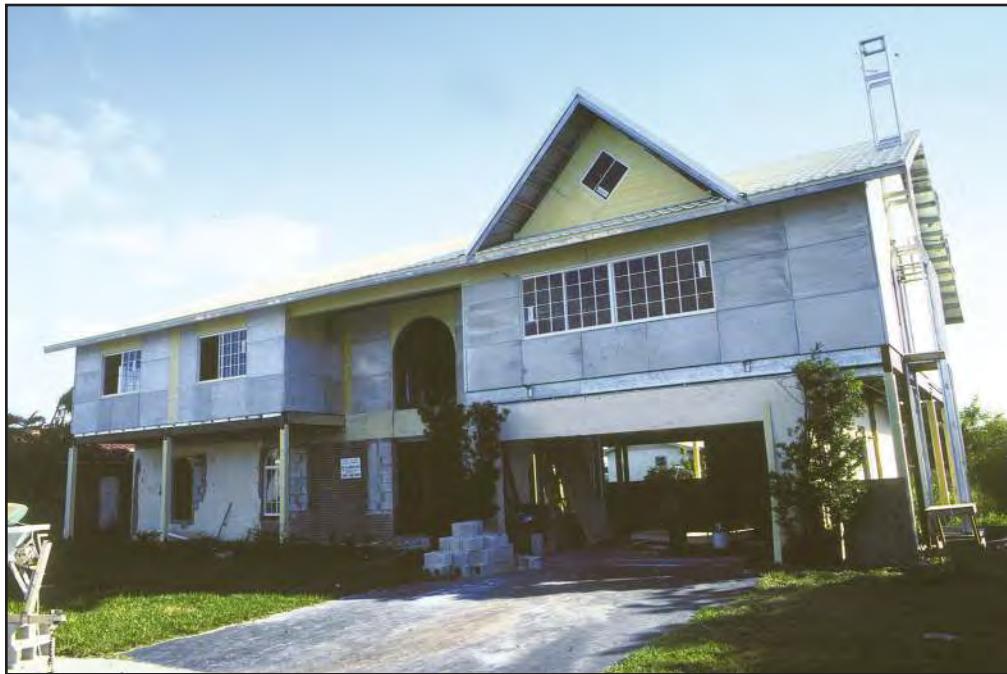
Figure 58

The new second story nears completion. The roof is made of formed metal panels.

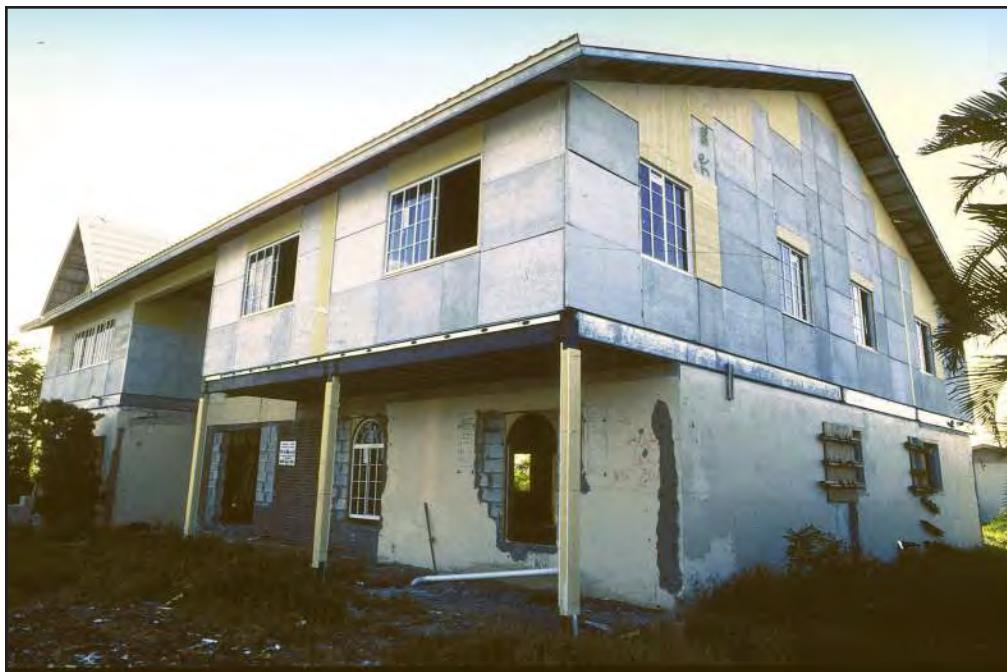
Figure 59

The exterior walls consist of prefabricated concrete panels. Innovative techniques such as those employed in this project are helping homeowners who need practical and economical methods of repairing and protecting their houses.
