Above the Flood: Elevating Your Floodprone House

FEMA 347 / May 2000

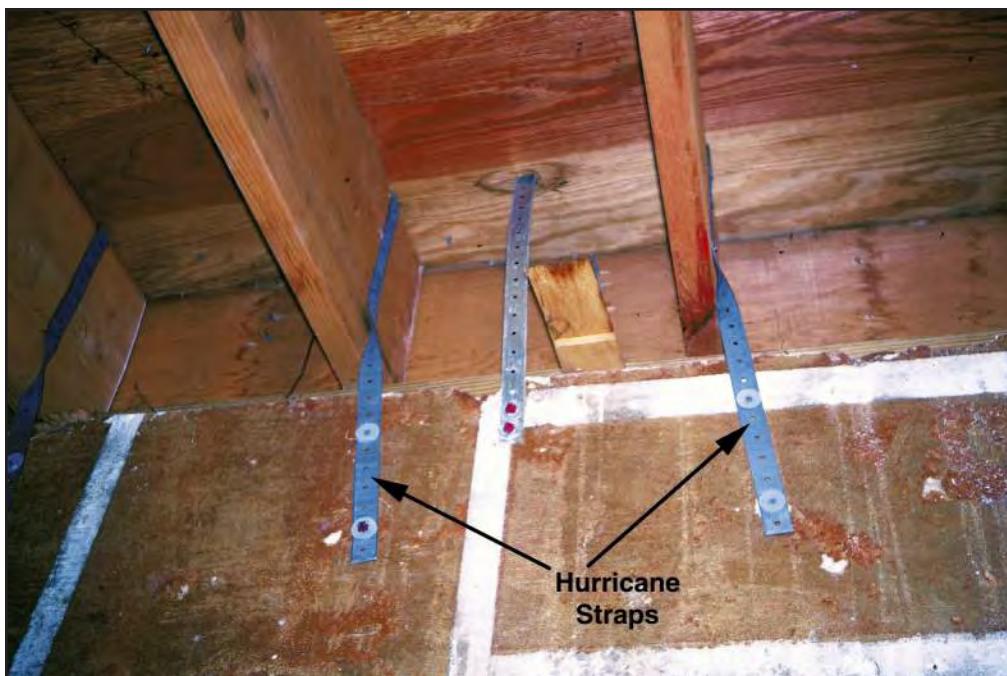
The new second-story walls are securely connected to the original first-floor walls with galvanized metal hurricane straps.

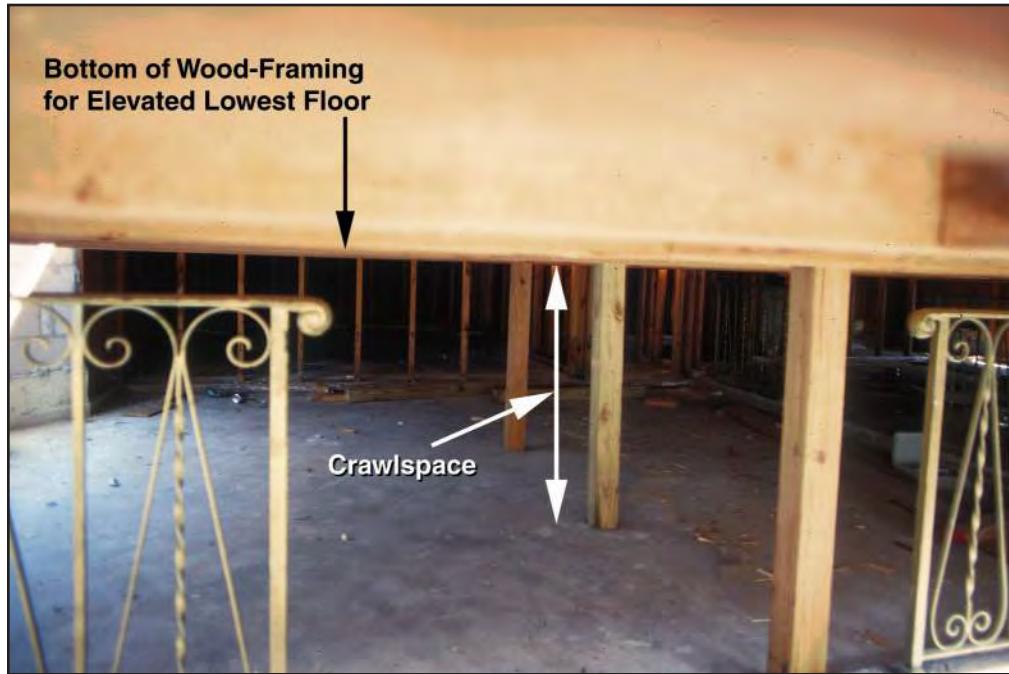
Figure 68

Rather than install a new concrete slab on compacted fill, the owner of this house chose to build a new wood-frame floor above the old concrete slab. This method creates a crawlspace below the new floor.

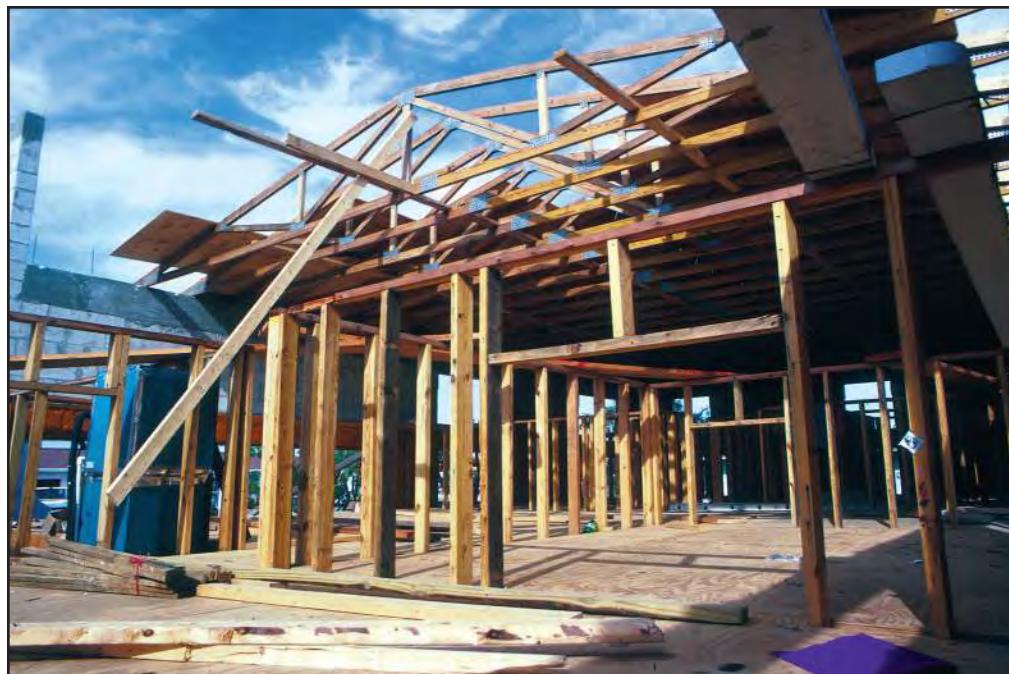
**Figure 69**

Wood framing is used for the new second story.

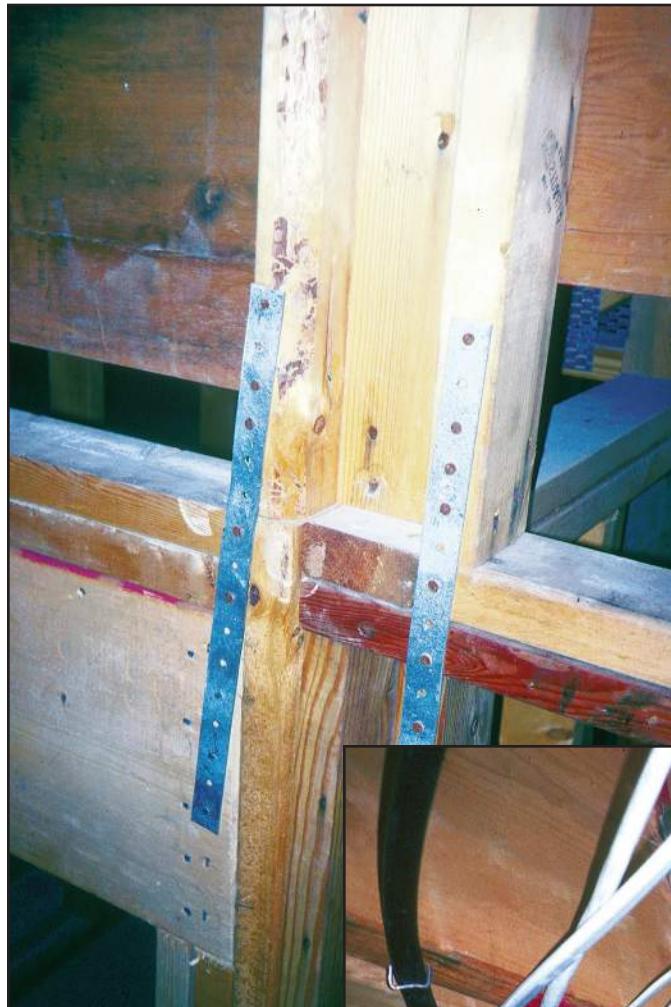
Figure 70

Metal hurricane straps are used to tie the structural members together and create a continuous load path from the roof to the foundation.

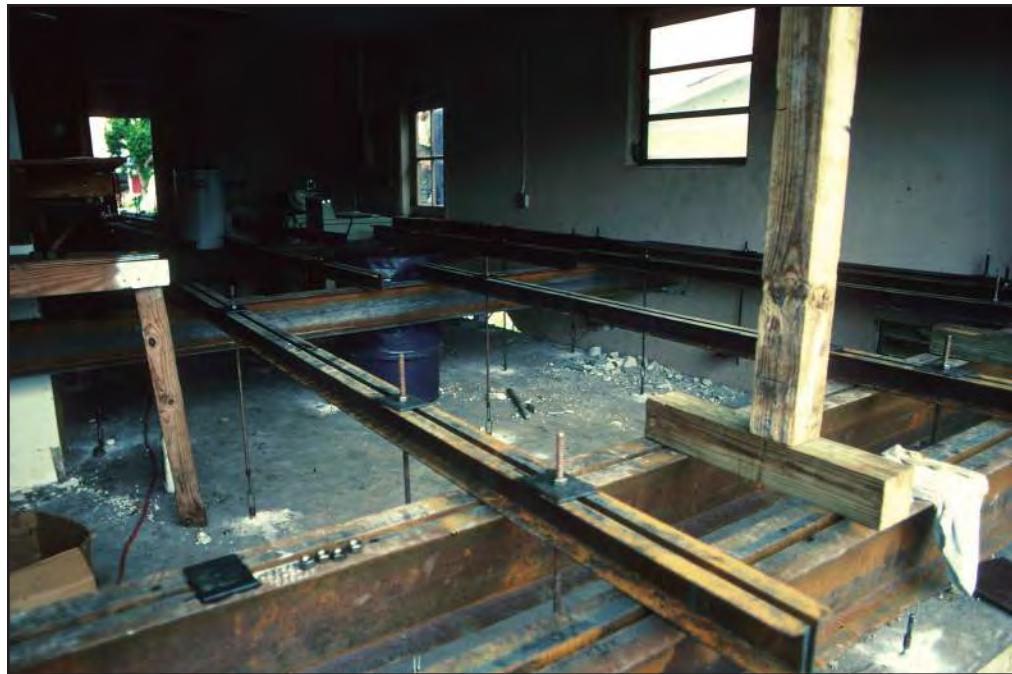
The anchors and hangers connect the slab securely to the beams, enabling the beams to raise the slab along with the rest of the house.

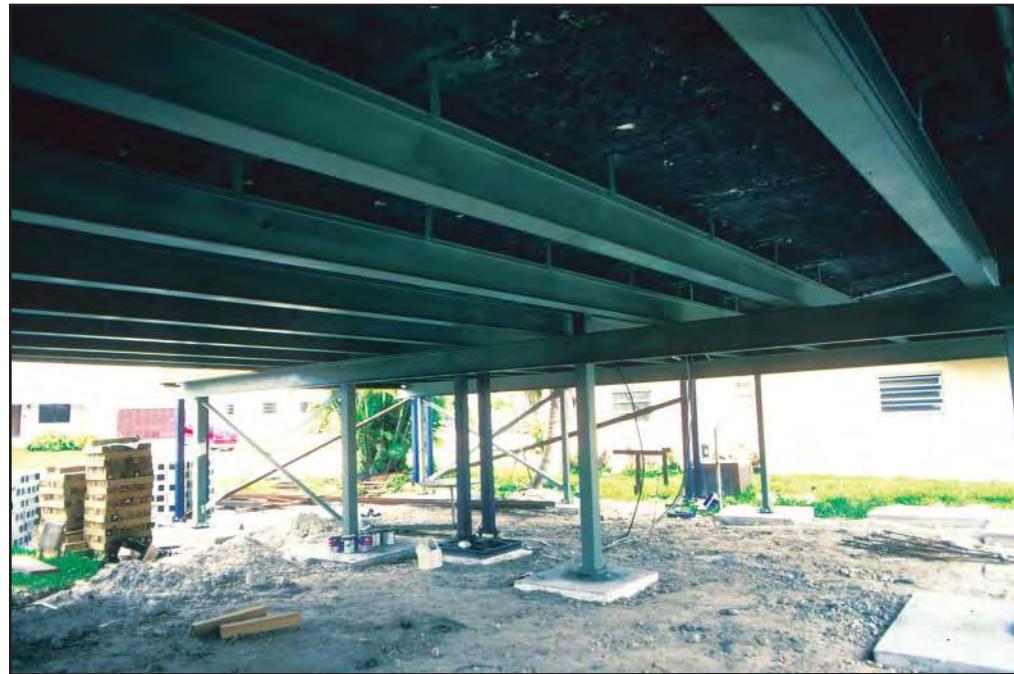
Figure 82

While the jacks and beams supported the house, new steel foundation members were installed below.

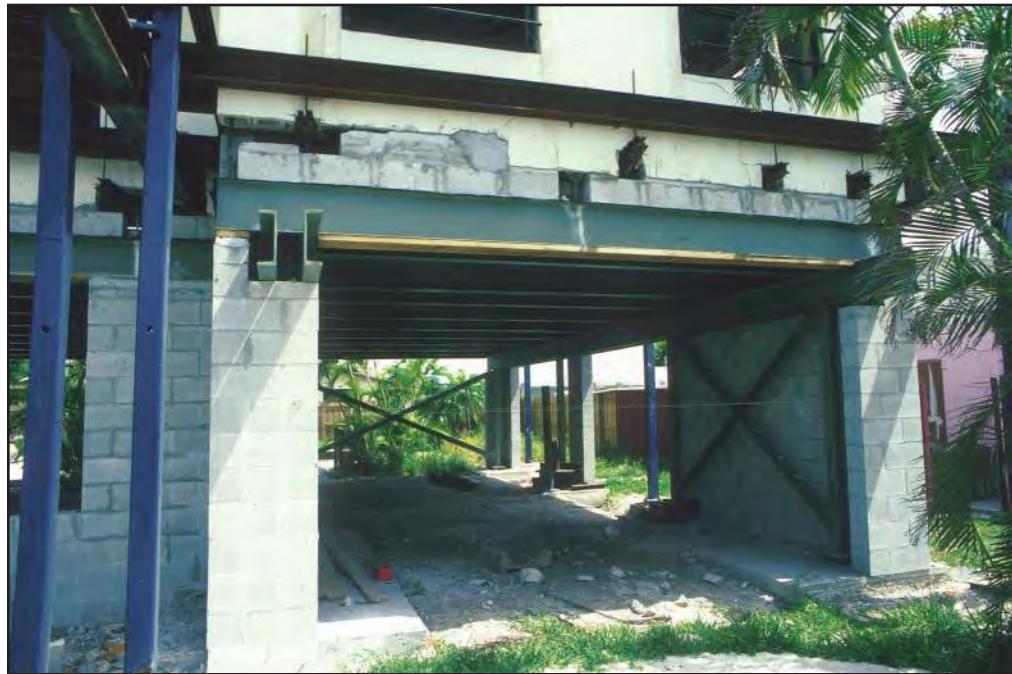
Figure 84

... and used to build the lower-level walls.
